# Analysis of Spontaneous Exodynamic Processes in the Dghviora River Basin Taking into Consideration the Perspectives of the Shovi-Glola (Georgia) Tourist Agglomeration

*Georgian Geographical Journal*, 2024, 4(1) 26-34

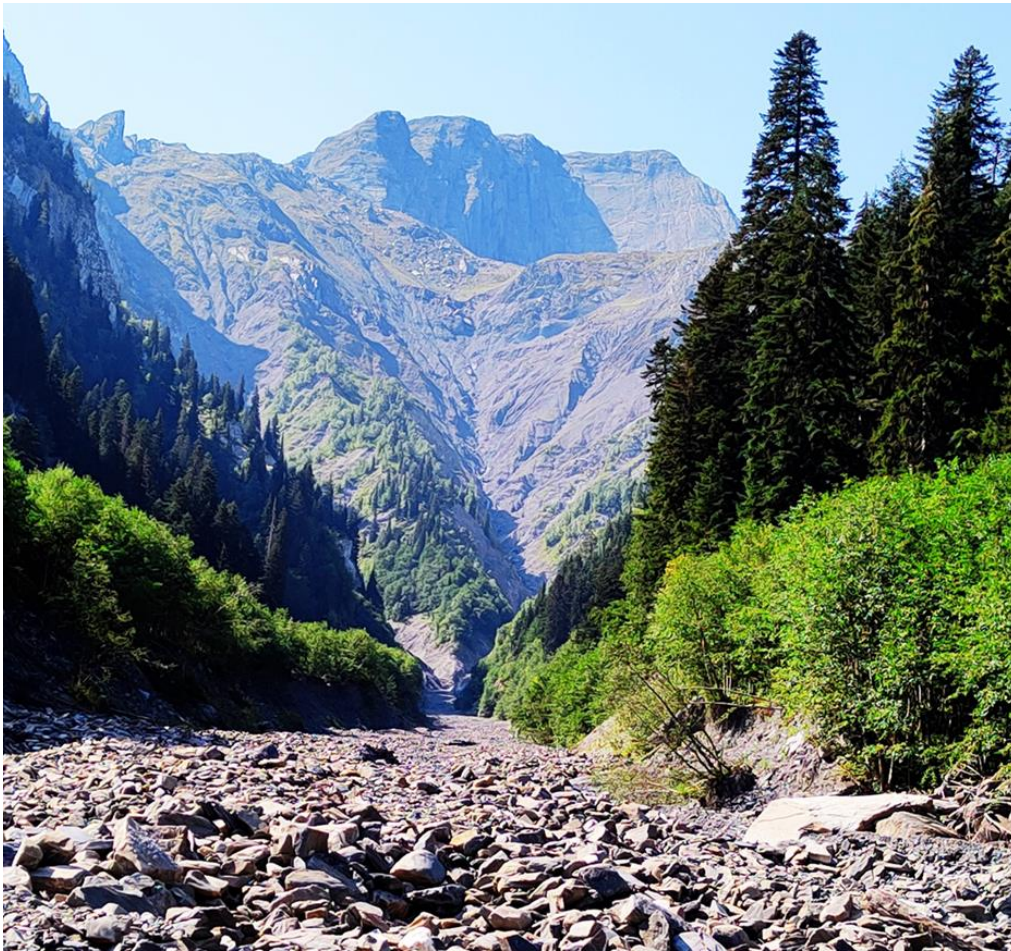
Figure 4. The head and bed of the Dghviora river

Two streams, which flow from the steep and weathered slopes of the Shoda-Kedela Ridge, join each other in the upper part of the river and form the main stream of the Dghviora River (Fig. 4). Disintegrated material, mainly in large fractions, falls from the head, and slopes accumulate there, periodically blocking the flow of the river and temporarily creating lakes. Over time, this natural dam is breached by excess water, and a torrent is formed. The width of the river floodplain reaches 50-60 m in this section, and the inclination of the bed is 15-200. The accumulated material consists of several fractions: single large boulders of 1.5-2 m in size, small boulders of 20-30%, and small pebbles of up to 70%.

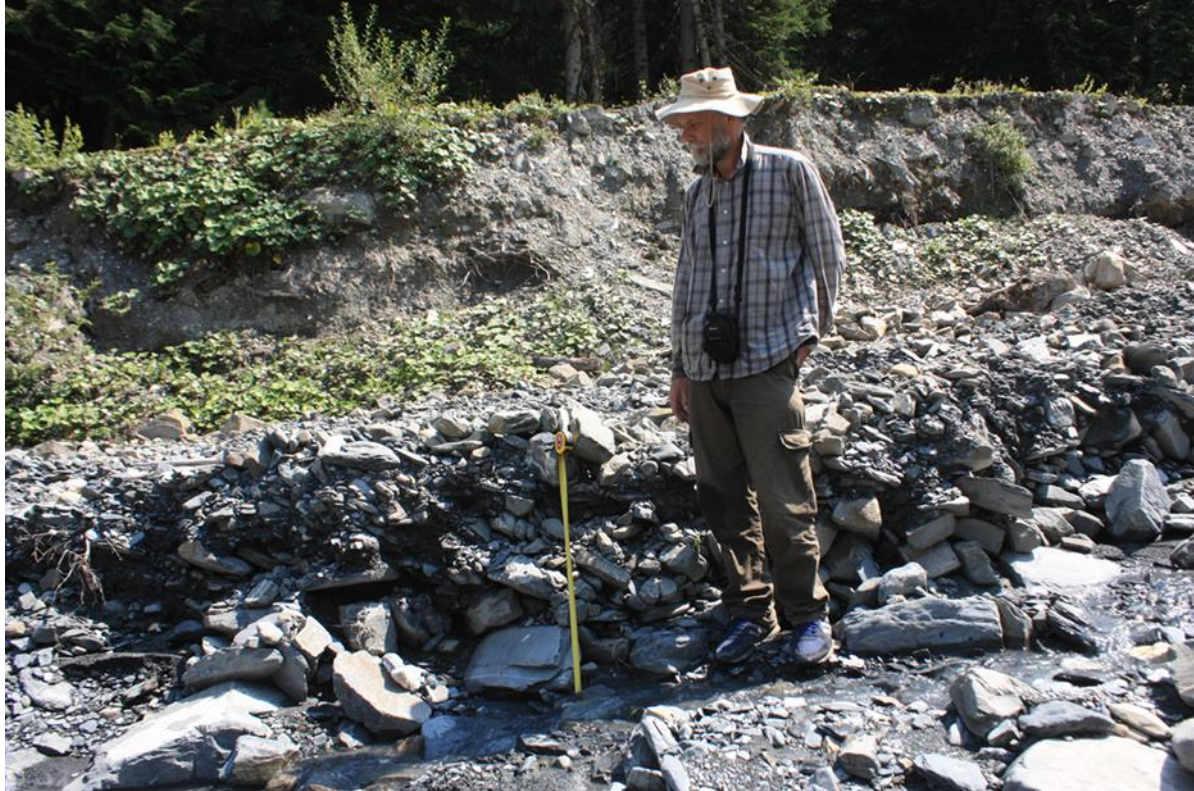
Figure 5. Typical composition sediments on the right bank of river Dghviora

In its new bed, at 1.2 km upstream of the confluence with Chanchakhi, riv. Dghviora has cut its accumulation material in several places. The bottom of one of the trenches (height 1,717 m above sea level, thickness 120 cm, width 250 cm) begins with a sand fraction (less than 0.5 cm), which occupies 15% of the trench volume. Then, a slightly larger fraction of less than 5 cm (12%) was observed. These layers are as follows: 5-10 cm fraction - 9%; 10-20 cm fraction - 12%; 20-35 cm fraction - 20%; and 15 cm layer with 10 cm interlayers of pebbles, sand and clay - 12%, fine gravel coarse material or less processed 35-50 cm - 20% (Figure 5).

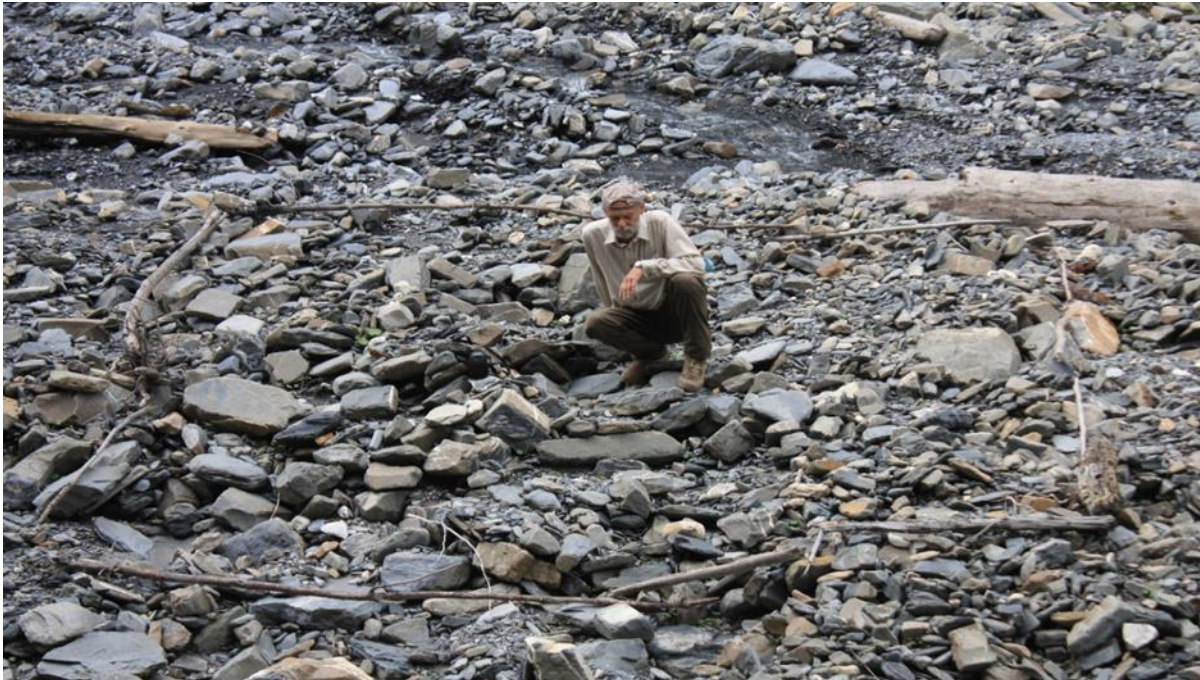
Figure 6. Granulometric polygon in the bed of Dghviora river

In the middle of the river, 120 m above the bridge, a granulometric polygon (20 m<sup>2</sup>) was set up to record the horizontal distribution of the solid sediment fractions of the river. The polygon consists of the following fractions: 0.5 m thick sand, clay and fine pebbles—25%, 5 cm thick sand fraction—13%, 5-10 cm sand and gravel fraction—11%, 10-20 cm thick sandy-pebble layer with inclusions of 15-20 cm boulders—10%, 20-35 cm thick boulders—8%, 35-50 cm thick boulders—11%, and 70 cm thick boulders—22% (Fig. 6).

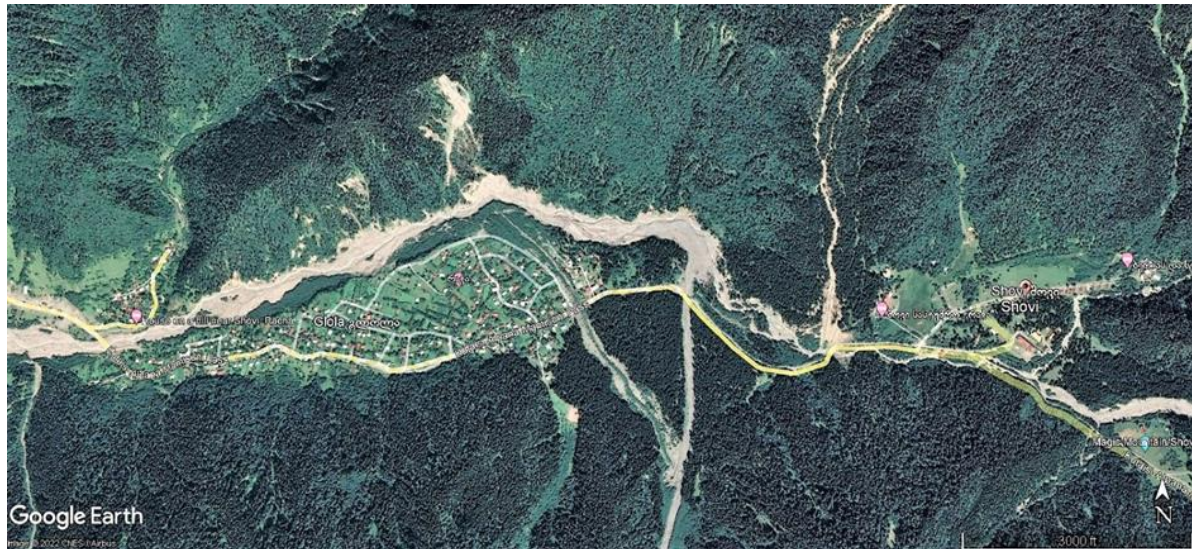
*Figure 7. Rural agglomeration Glola-Shovi, emerging as a tourism cluster. In the center of the image, you can see the result of the shifting of the bed of river Dghviora to the east, which saved the settled part of village Glola from the danger of a catastrophic mudflow. Source: Google Earth*

Changes in the Dghviora riverbed have saved the important village of Glola from the ever-increasing threat of mudslides. Before the relocation, the continuously cultivated bed of the Dghviora River passed through its territory.

The village is located on the southern slope of the main watershed of the Caucasus, 25 km from Oni, at an average of 1,275 meters above sea level; it opens to the west to the Rioni valley, and the other three sides are surrounded by mountains covered with coniferous forests. Notably, this area is an important section of the northern border zone of Georgia (Fig. 7).
