# Exodynamic Processes in Upper Racha

*Georgian Geographical Journal*, 2025, 5(2) 4-11

## Abstract

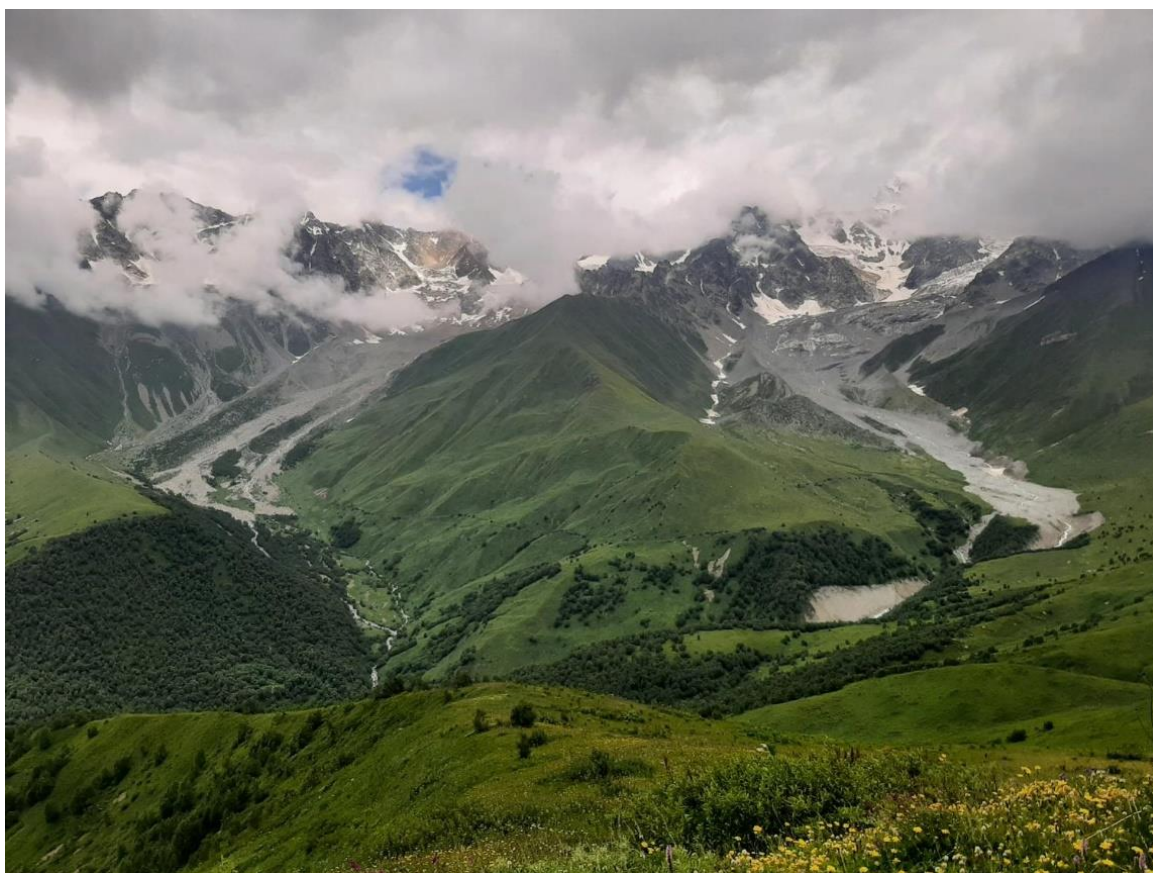
Figure 1. Glaciers Tbilisa and Buba. Photo by M. Gongadze

Geologically, the northern flank of the Upper Racha syncline is dominated by thick-bedded marls of Upper Jurassic age, carbonate shales, and interbedded limestones. Lower Cretaceous tectonic activity has generated folded structural formations, while the area is intersected by both young and ancient faults oriented along multiple latitudinal directions. These structures are further complicated by strike-slip and discontinuous dislocations, which strongly influence the morphology and stability of the terrain. Quaternary sediments—including eluvial, deluvial, colluvial, alluvial, proluvial, and fluvioglacial deposits—form a significant component of the surface cover, influencing hydrological dynamics and slope processes (fig. 1).

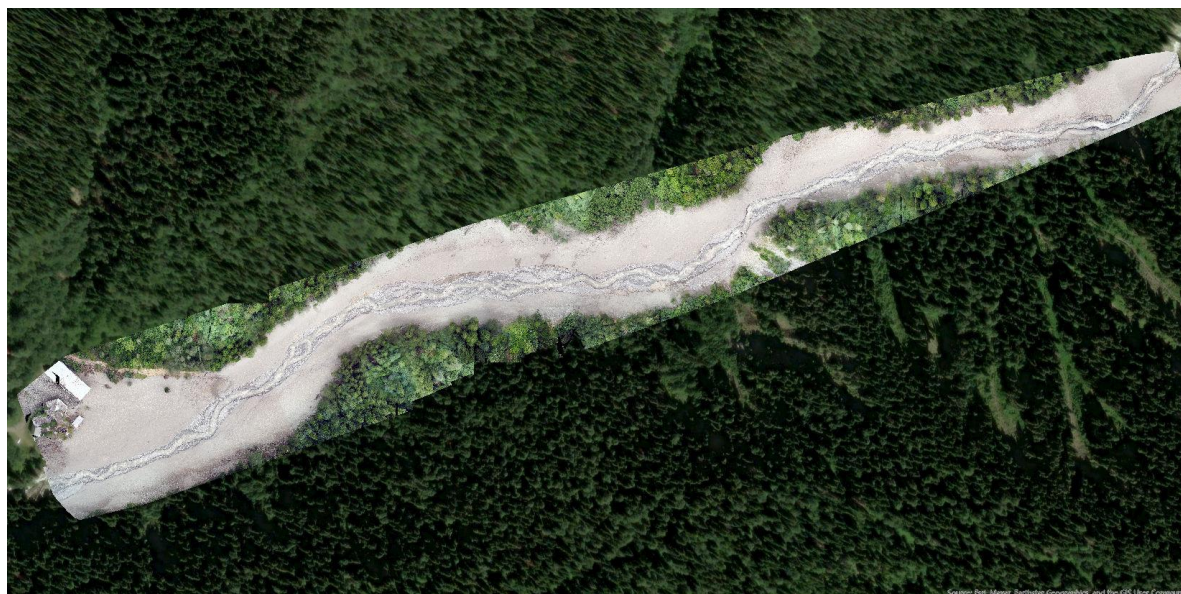
Figure 5. River Bubistskali gorge in the Shovi section after the disaster. Source: Esri, Maxar, Earthstar Geographics and the GIS User Company

At the end of July 2023, Upper Racha experienced extreme heat followed by torrential rains, leading to a critical event in early August. The intense rainfall and melting snow increased the saturation of the moraine material, surpassing its critical threshold. This destabilised the gravitational equilibrium of the solid material, causing rainwater, melted snow, and a swollen river flow to mobilise a large number of debris. As it moved downhill, the mass uprooted coniferous vegetation and quickly advanced towards Shovi. The Bubistskali River, being short in length, was covered by the catastrophic mudflow in just 20 minutes (fig. 5).
