# Natural Events Related to Hydrological Processes and Ways to Avoid Them in the Tourist Area of Adjara

Georgian Geographical Journal, 2026, 6(1) 21-28  
© The Author(s) 2026

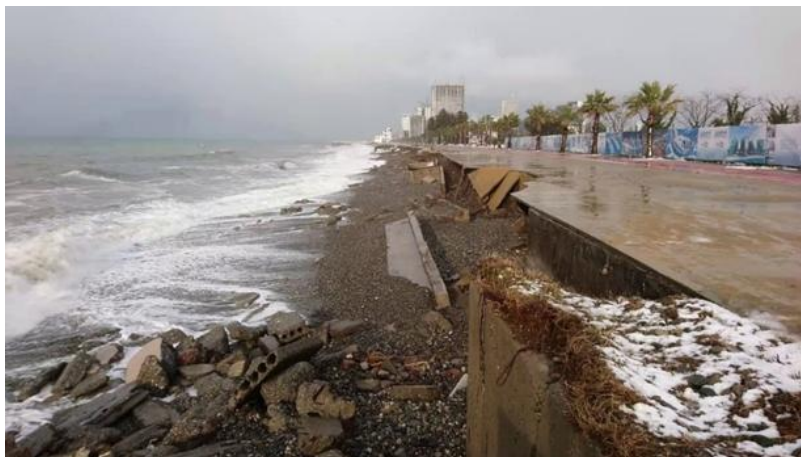
Figure 4. Batumi, New Boulevard. February 17, 2017. (YouTube, n.d.)

Adjara has risen by 22-25 cm during the last century, the result of which is that during the intrusion of the sea, the marine erosion has intensified along the coastline. And then brackish water causes bank erosion. If this includes agricultural fields and beaches, they are already severely eroded, easily flooded and destroyed by seawater. In addition, the power of storms is increased, seasonality also changes the characteristics of floods. Which is confirmed by many photo materials (Fig. 4).

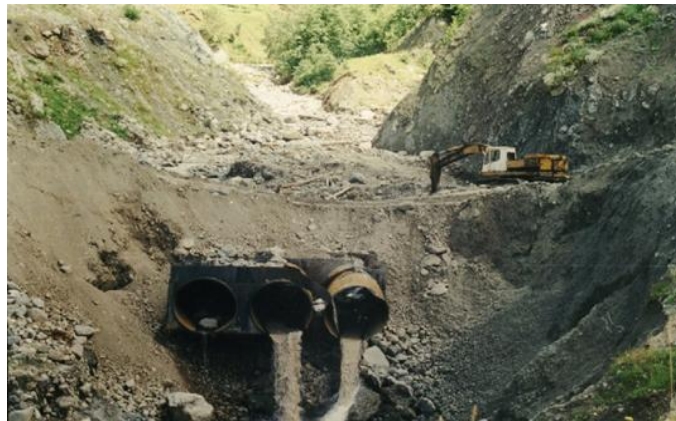
Figure 5. River Safristskali valley 2005 (photo by S. Gorgijanidze)

The activation of landslides, which occurs almost every year, is also dangerous, as a result many residential buildings are damaged or destroyed, agricultural fields are damaged. Sometimes this process is accompanied by the blocking of riverbeds, which causes water stagnation. As a result, it is possible to breach a naturally dammed lake, which is accompanied by strong floods. A sharp increase in the level of the rivers in the entire valley is common, and the consequences of floods are always negatively reflected both in the mountainous Adjara and in the downstream of the rivers. Due to heavy rains, landslides often occur in valleys, and floods and debris flows occur on rivers. Such cases are frequent, for example, in 2005, the flood occurred on the Safristskali River, which damaged the surrounding road, destroyed bridges and disabled highways (Fig. 5). Such an event was repeated in 2021 and again damaged the surrounding areas and roads (Fig. 6).

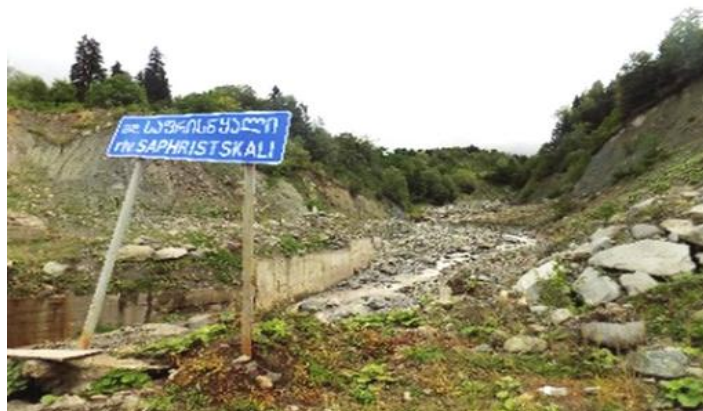
Figure 6. River Safristskali valley 2021, (<https://geologymaps.ge>)

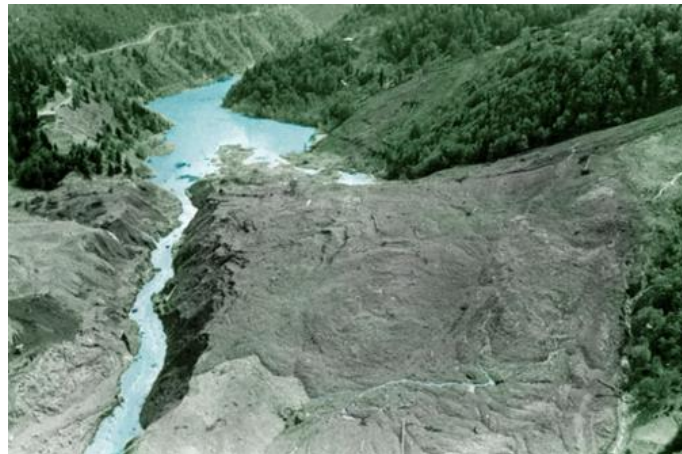
Figure 7. Skhalta Dammed Lake and Skhalta River (1989 photo by V. Tsomaia)

A similar process took place in 1989 at river Skhalta. A flooded lake appeared. It was the result of blocking the valley by a landslide that came as a result of intense rains. (Fig. 7).

If there was no place for its breakthrough and the related catastrophic flood, the channel was made. As a result, the flooded water went down, and a dangerous debris flow was avoided.
