RESEARCH OF OGHASKURA RIVER BED PROCESSES AND RELATED CIRCUMSTANCES UNDER THE NATURAL CONDITIONS

Abstract. The thesis presents the changes in the bed processes of the River Oghaskura over the years and the research results of the work carried out in nature by the expedition in 2023.

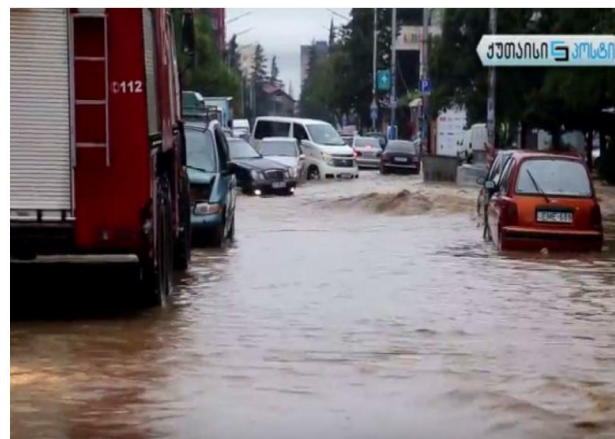
The bed of the River Oghaskura within Kutaisi is heavily polluted with household, construction and other types of waste. At first glance, the seemingly calm and harmless small mountain river Oghaskura overflows its bed during the rains and floods the entire settlement long the river (Find, fig. 1), which poses a danger to the settlements.

Fig. 1. The river Oghaskura in Kutaisi overflowed the bed and partially flooded Bukhaidze Street.

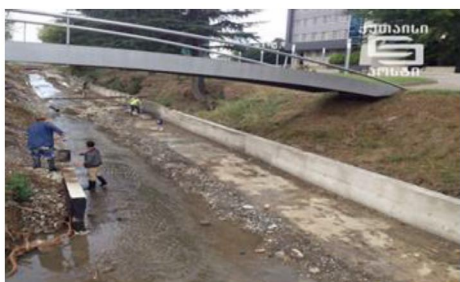
According to the tender documents, the project should be prepared for the reconstruction of the sections located along Daniel Chonkadze and Automshebeli avenues (Find, fig. 2). The goal of the project is expansion - cleaning of the river Oghaskura bed, the strengthening of the river banks with monolithic concrete, during heavy rainfall, the river Oghaskura in order to reduce the risk of flooding the surrounding area of Oghaskura.

Fig. 2. In Kutaisi, the reconstruction of the river Oghaskura bed and the bridges on it.

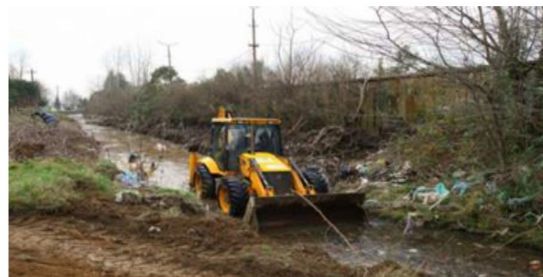
Due to sand and bottom sediment accumulated at different times (Find fig. 3), the river bed was reduced to 3-4 meters in width, now it will expand to 7.0 meters, which means that it has returned to the old mark. In addition, one meter of land was cut in the bed of Oghaskura river so called the bed depth increased by one meter.

Fig. 3. In Kutaisi, in front of "Hualing" at street of Automshebeli during the conducting the cleaning works of Oghaskura River.

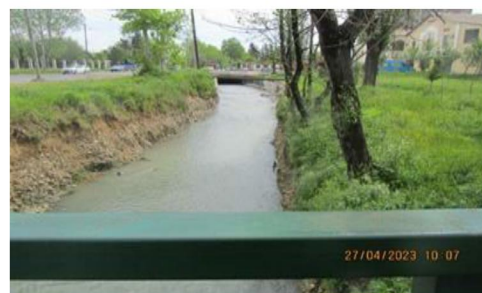
Within Kutaisi, separate sections of the riverbed of Oghaskura are very well cleaned, which is clearly visible (Fig. 4).

Fig. 4. View of the River Oghaskura upstream, from the metal bridge, to the point of outflow from the artificial bed

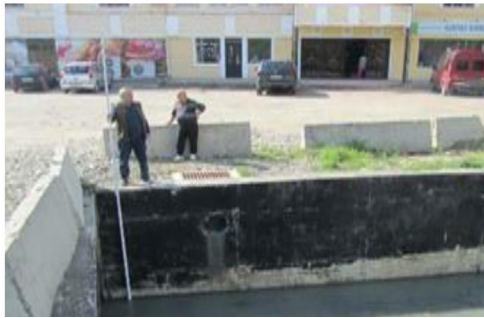
Fig. 5. Is presented on April 27, 2023, at the moment of measuring the water level of the left bank of the river Oghaskura and at the reinforced concrete bridge connecting the right and left banks of Oghaskura.

The figure 5 shows the cross-section of Oghaskura with the reinforced concrete bridge connecting the right and left banks, as a result of hydrological observation in nature, the depth of the flow in the said section is $h = 16.0$ cm, the height of the embankment wall is $H = 2.31$ m. The average speed of the stream movement is 0.67 m/s, the flow rate of the stream is 0.804 m³/s.

The river when it flows from the artificial rectangular reinforced concrete bridge. During the measuring hydrological works, we have determined that the water level at the right bank is $h = 16$ cm, the height of the bank is $H = 2.2$ m (Find, fig. 5) the average speed of the stream movement is 0.67 m/s, the flow rate of the stream is 0.804 m³/s.

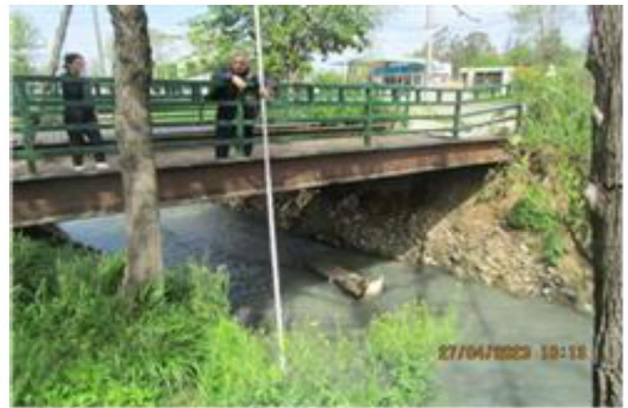
away. The average speed of the stream movement is 0.71 m/s, the flow rate of the stream is 0.804 m³/s. The river at the metal bridge on the right bank of Oghaskura bed, water level $h = 18.5$ cm, bank height $H = 3.08$ m. The average speed of the stream movement is 0.67 m/s, the flow rate of the stream is 0.804 m³/s. As can be seen from the picture (Find fig. 6), the right bank of the river Oghaskura is higher than the existing metal bridge, $H = 3.34$ m. The length of the metal bridge construction is $L = 9.4$ m. (Find fig. 6. Oghaskura River at the metal bridge ($L = 9.4$ m.), at the time of water level measurement).

Fig. 6 Iron bridge of river Oghaskura.

Picture 6 shows the left bank of the river Oghaskura. The water level of the left bank measured at the metal bridge is $h = 23.0$ cm, the height of the bank is $H = 3.08$ m. The average speed of the stream movement is 0.76 m/s, the flow rate of the stream is 0.804 m³/s. The lower height of the metal bridge from the river bed is $H = 2.6$ m.
