STUDY OF DAMAGE QUALITY OF TAO-KLARJETI TEMPLES

Abstract

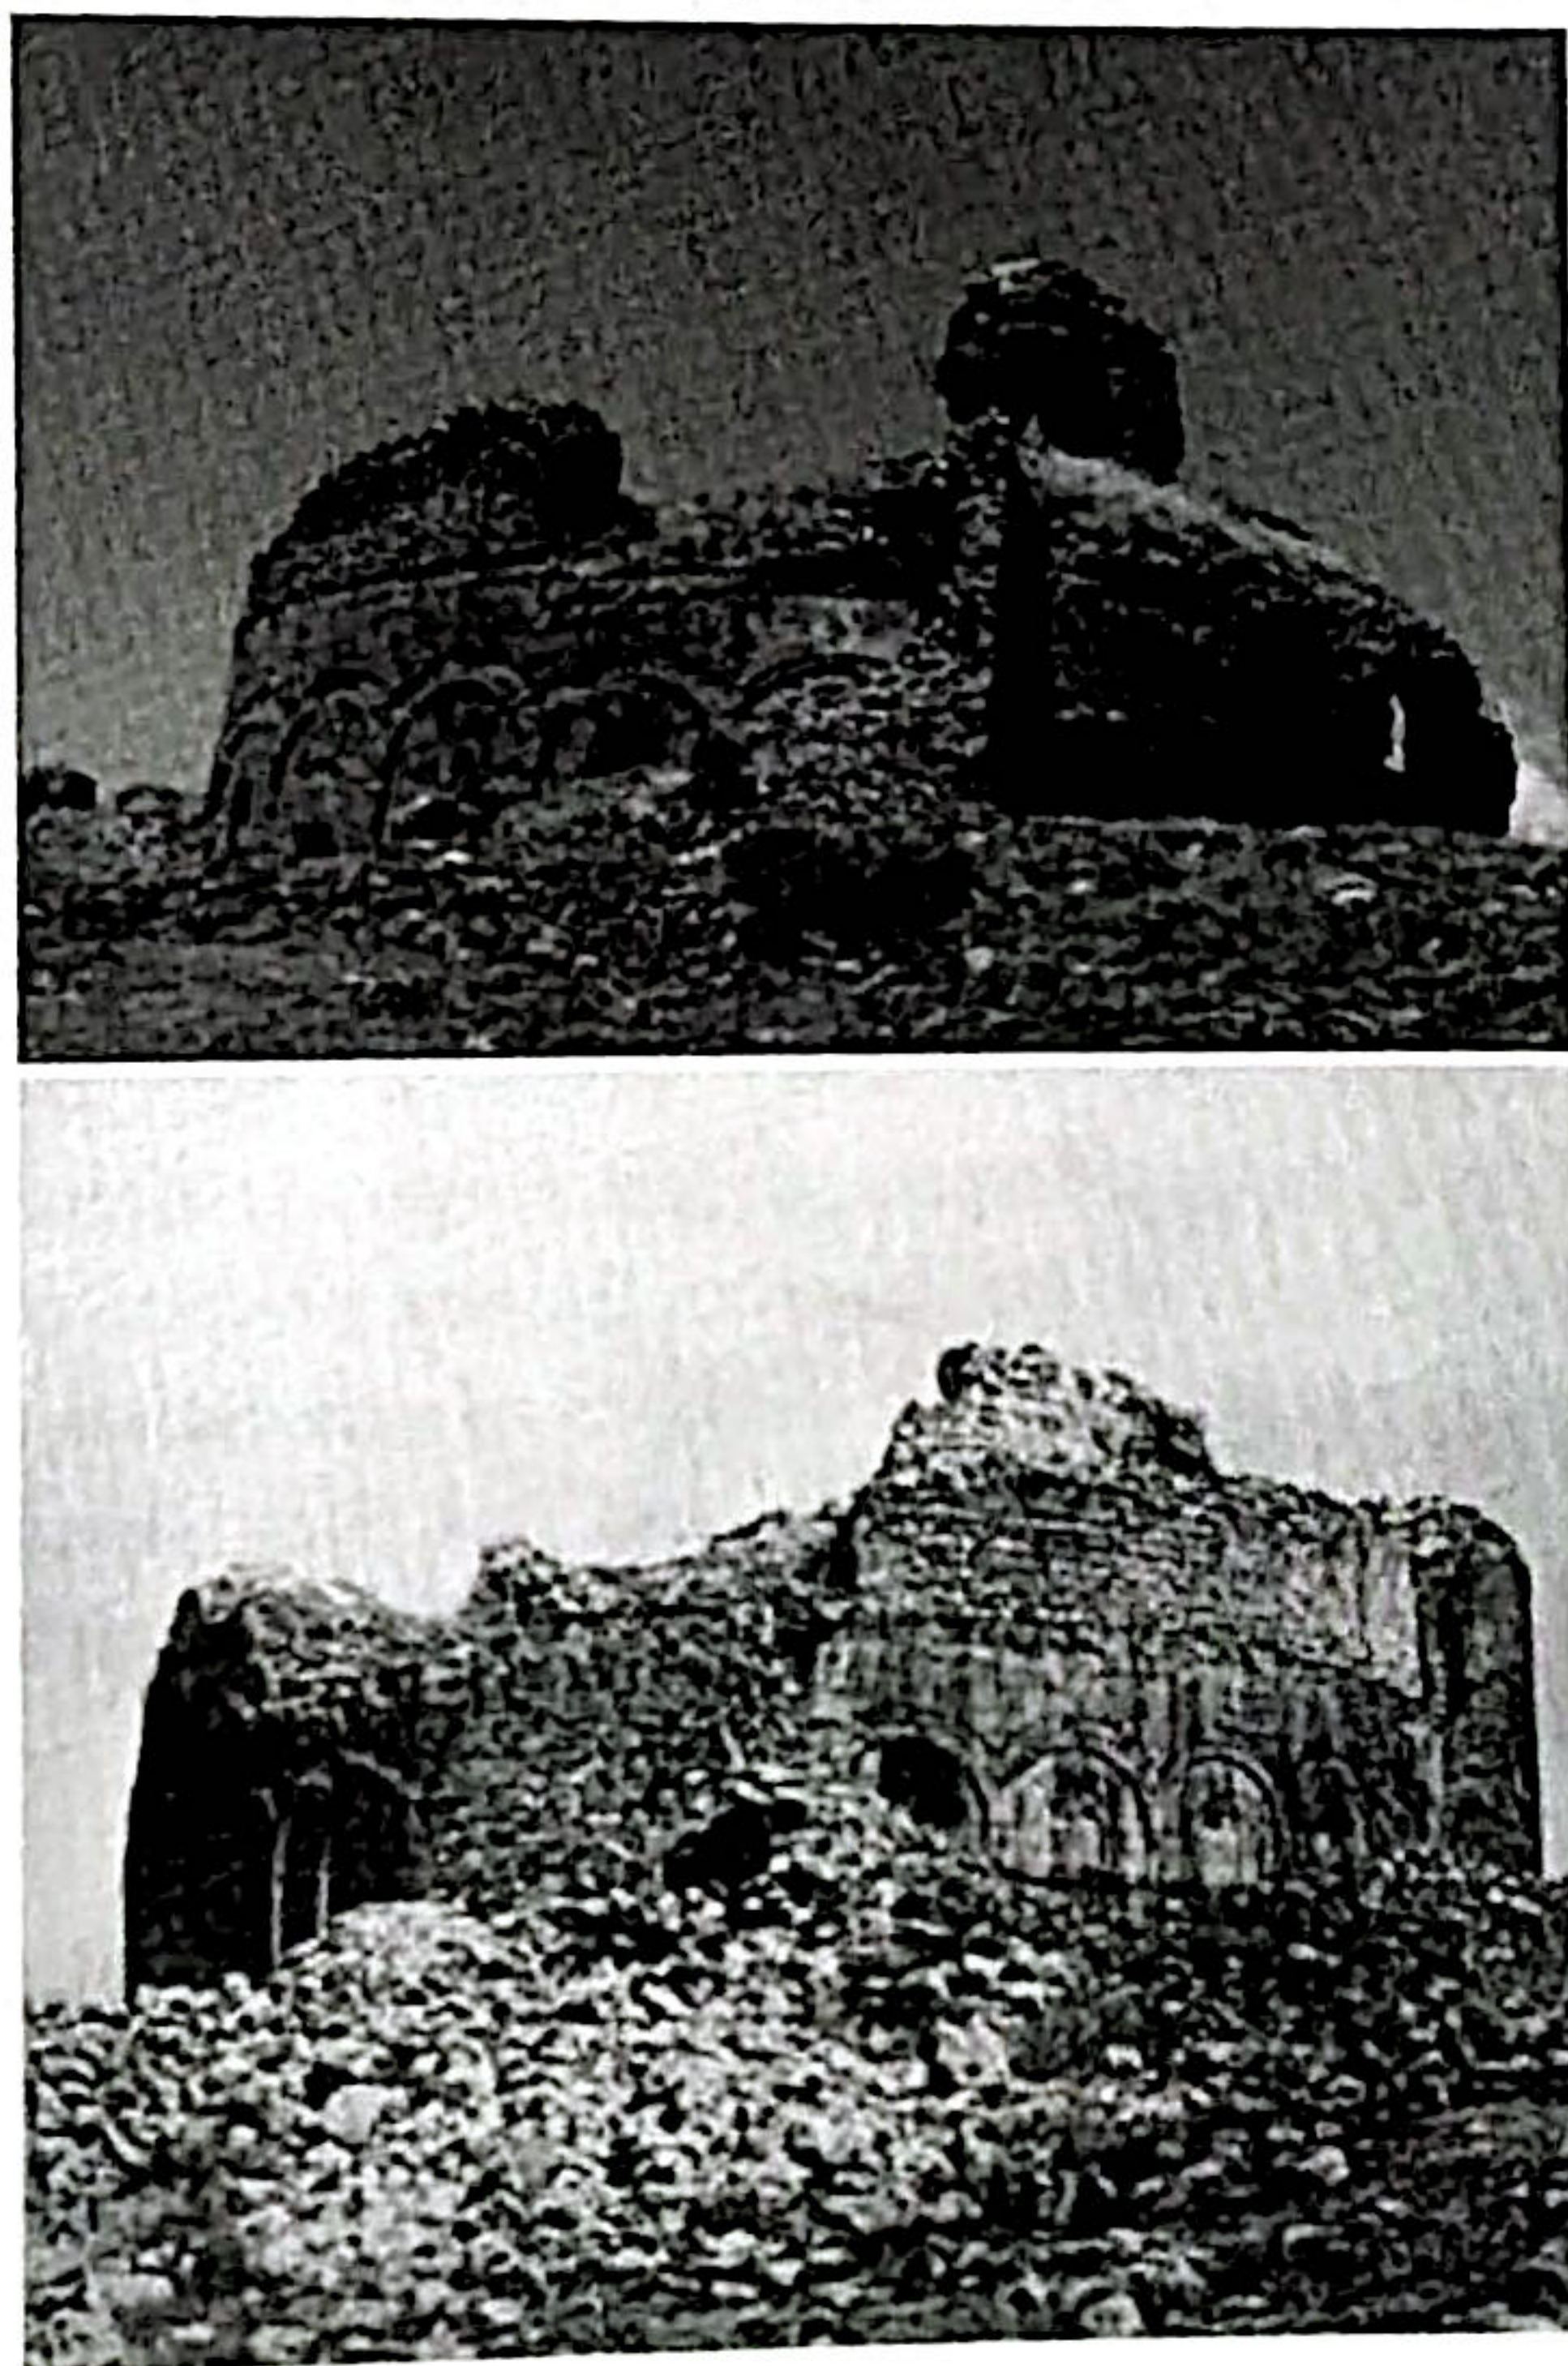
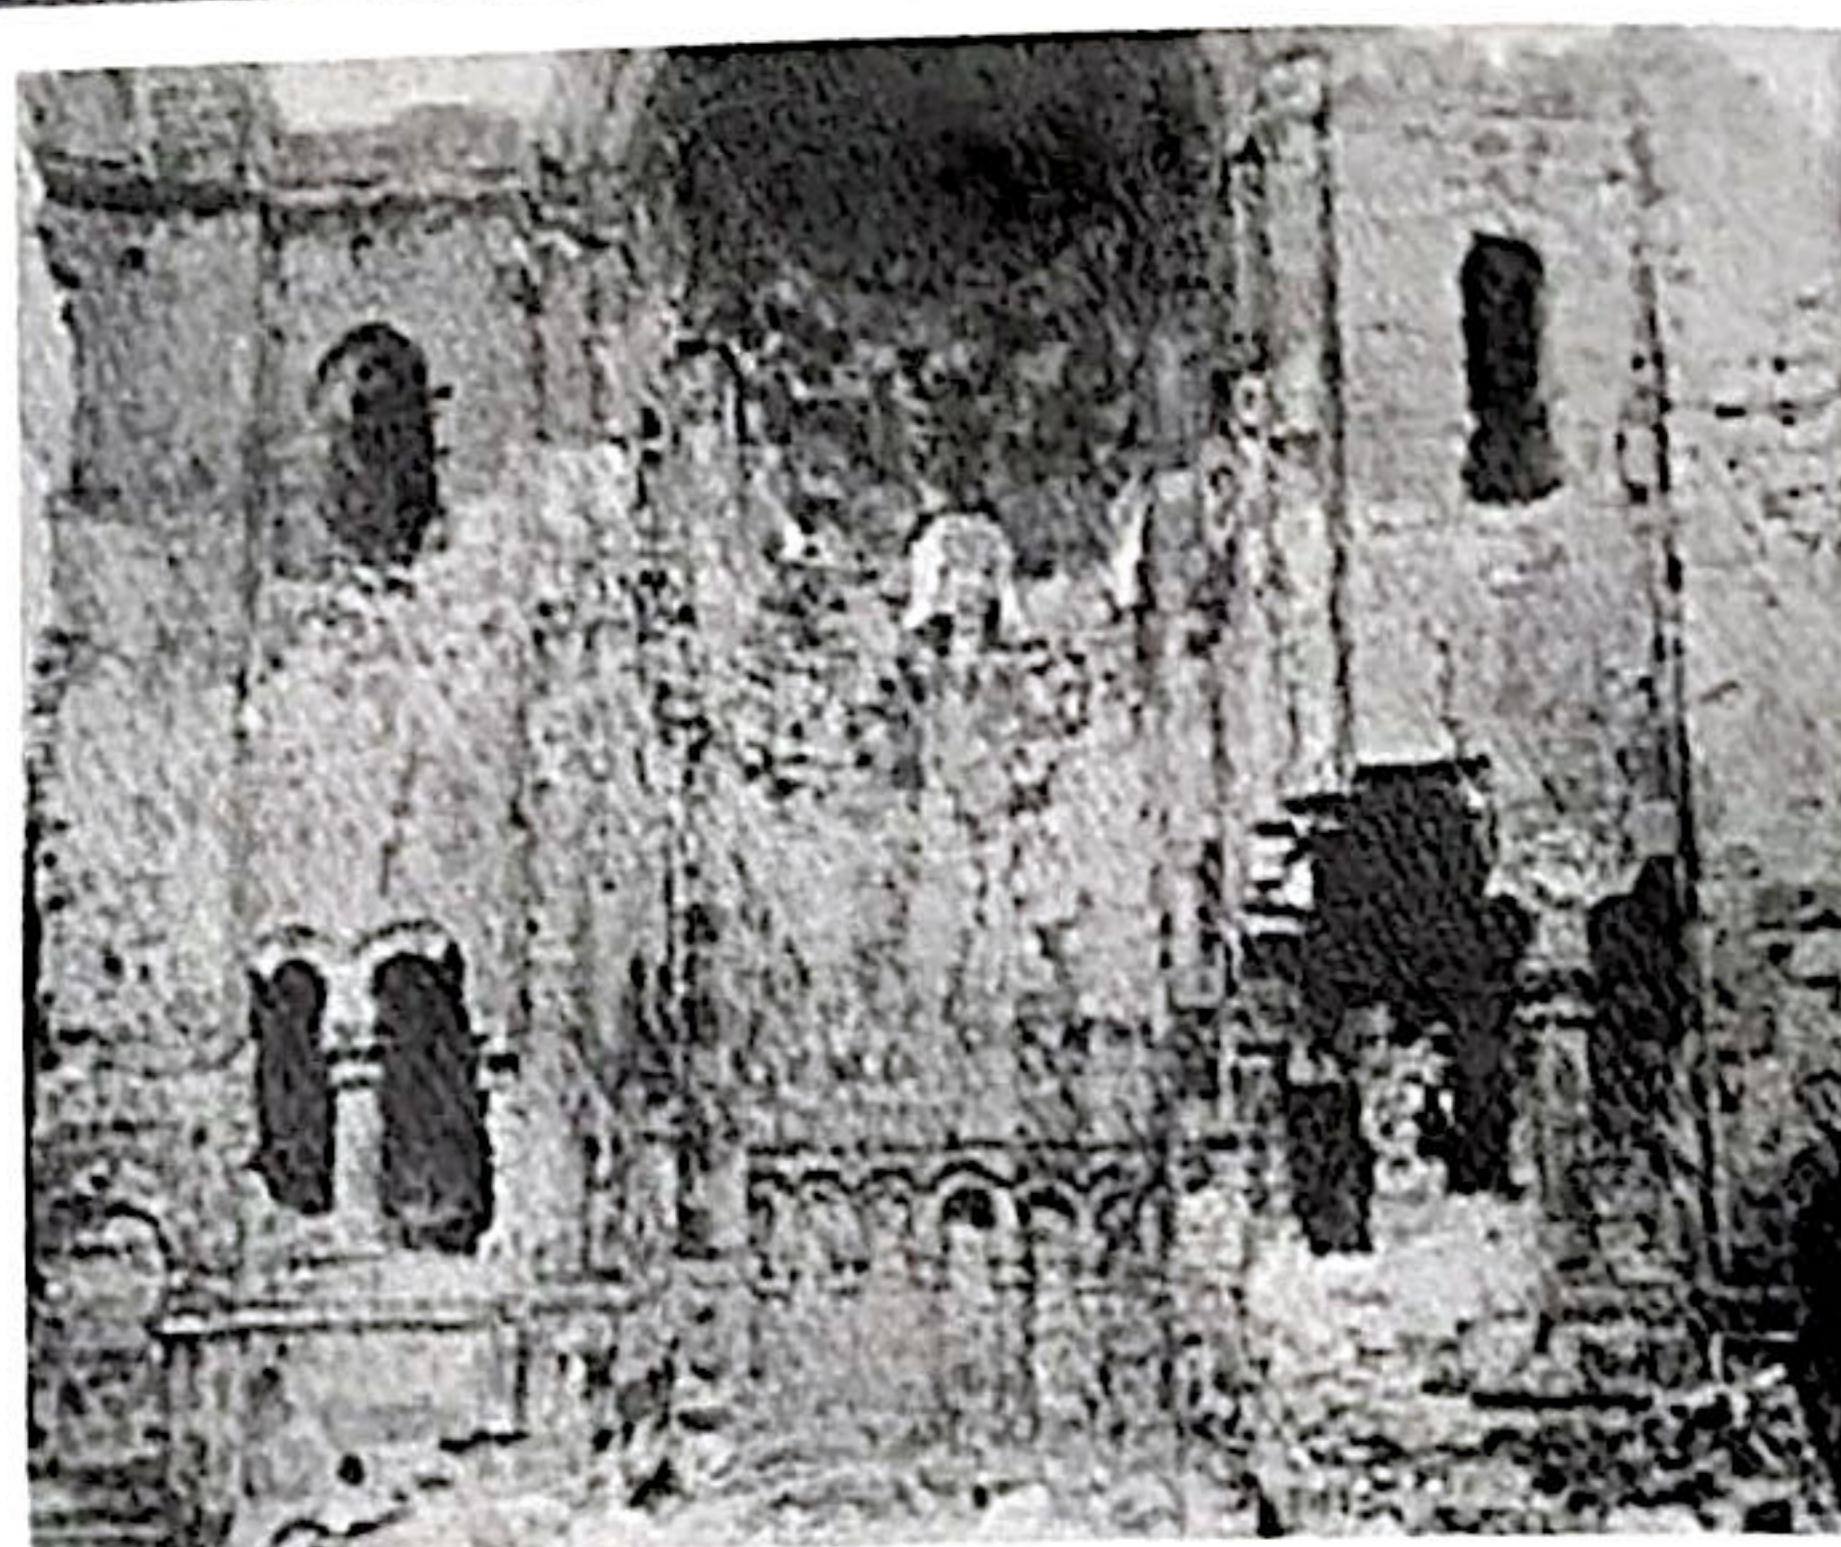
Fig. 1. Bana

Empire, Georgian Christian churches found themselves in a deplorable state. During the Russo-Turkish war in the 19th century, the Turks used the temple as a fortress, which made it a terrible target for Russia. This further damaged this magnificent temple. It can be seen from the pictures that the dome of the temple has collapsed, there is no longer a dome neck. The railings on the walls are cracked. None of the 8 columns that supported the dome have survived, the wall on one side has completely collapsed. In terms of restoration and strengthening, the situation here is very difficult. My dissertation cannot deal with these difficulties. Here, perhaps, the conservation method will be more useful than restoration.

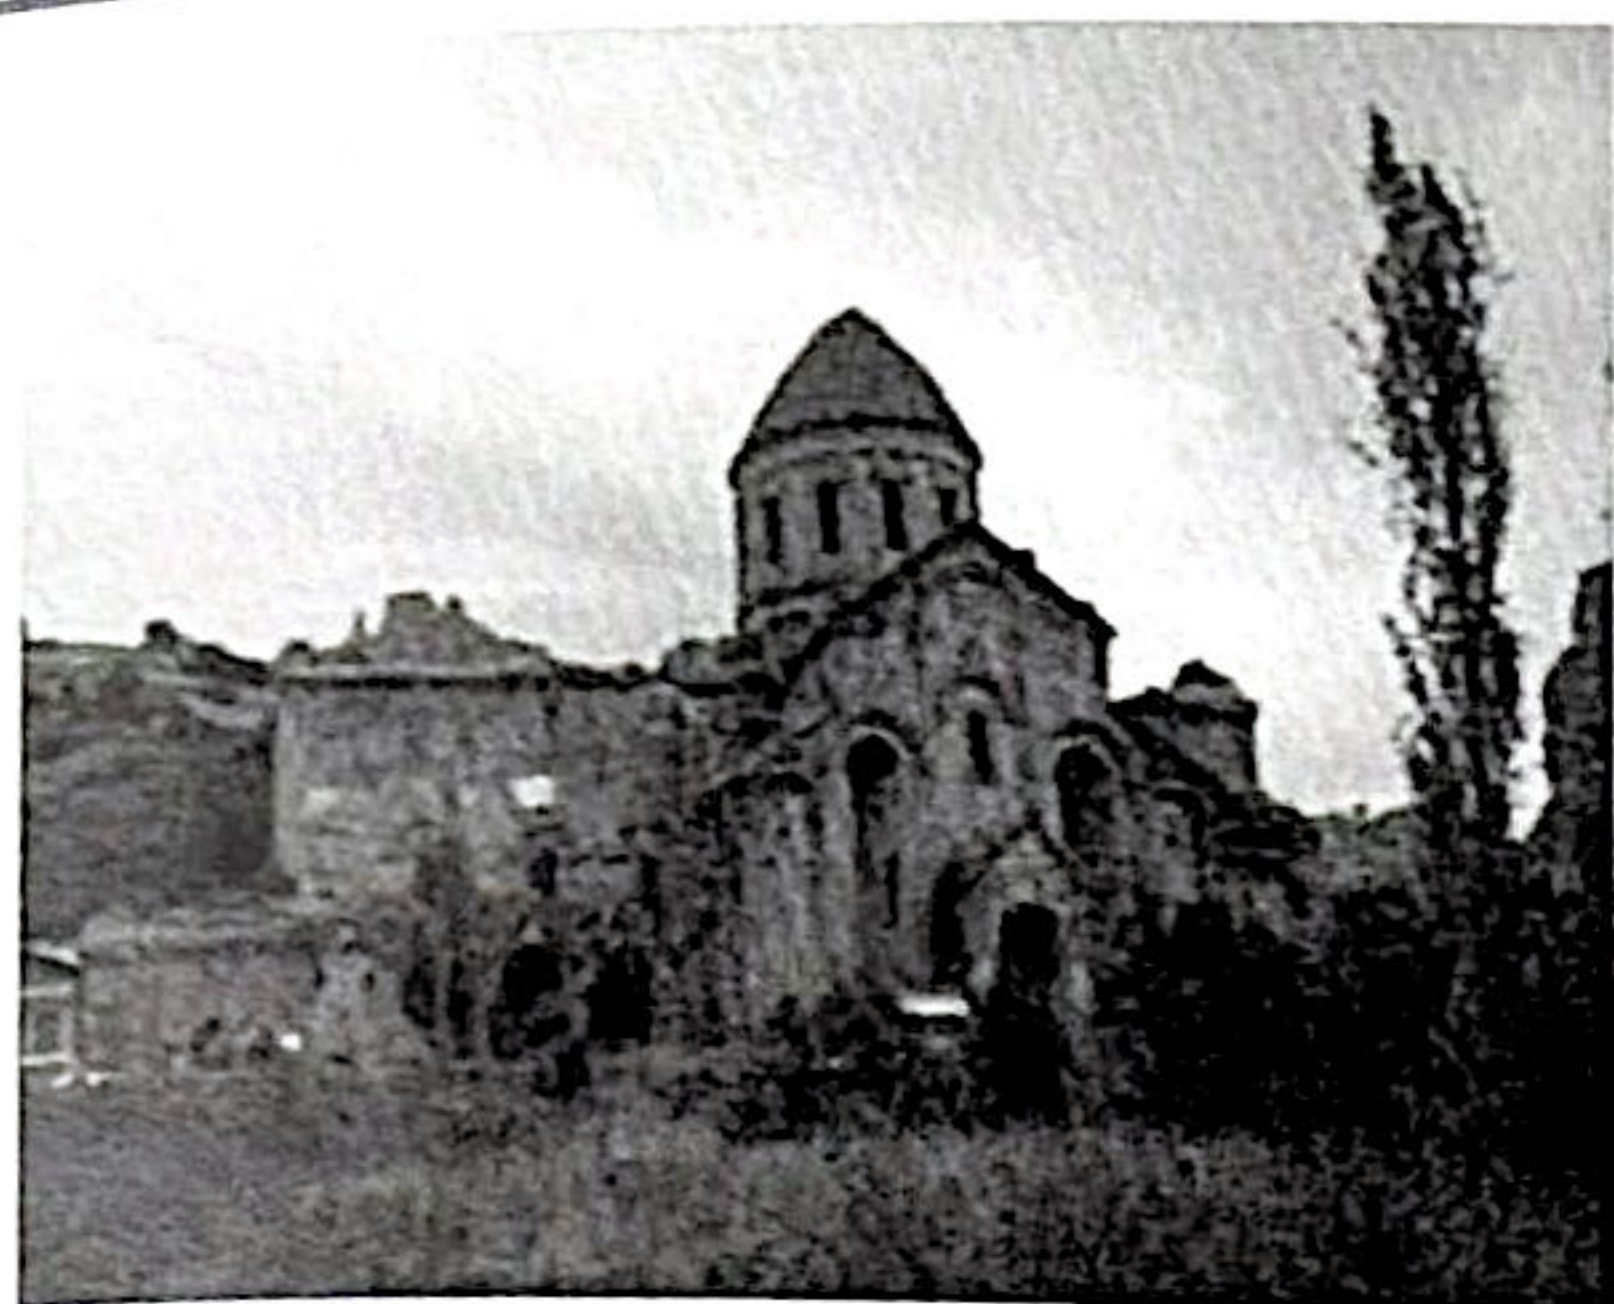
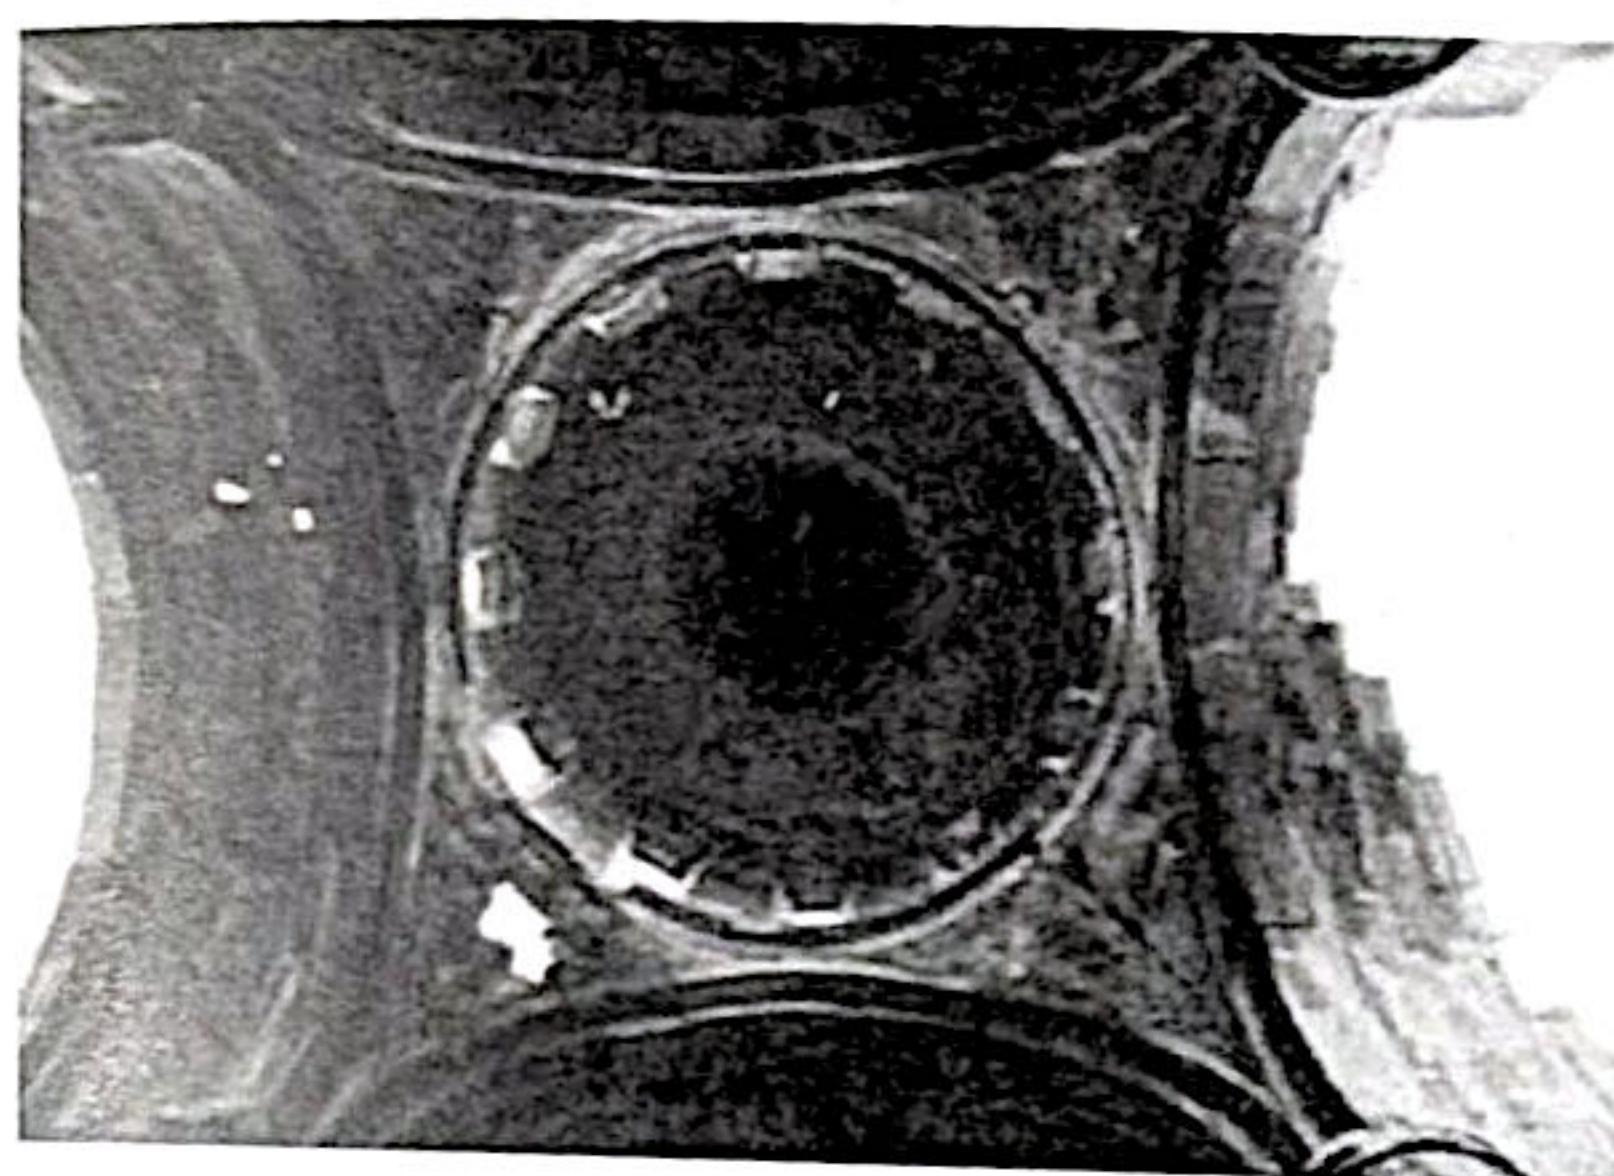
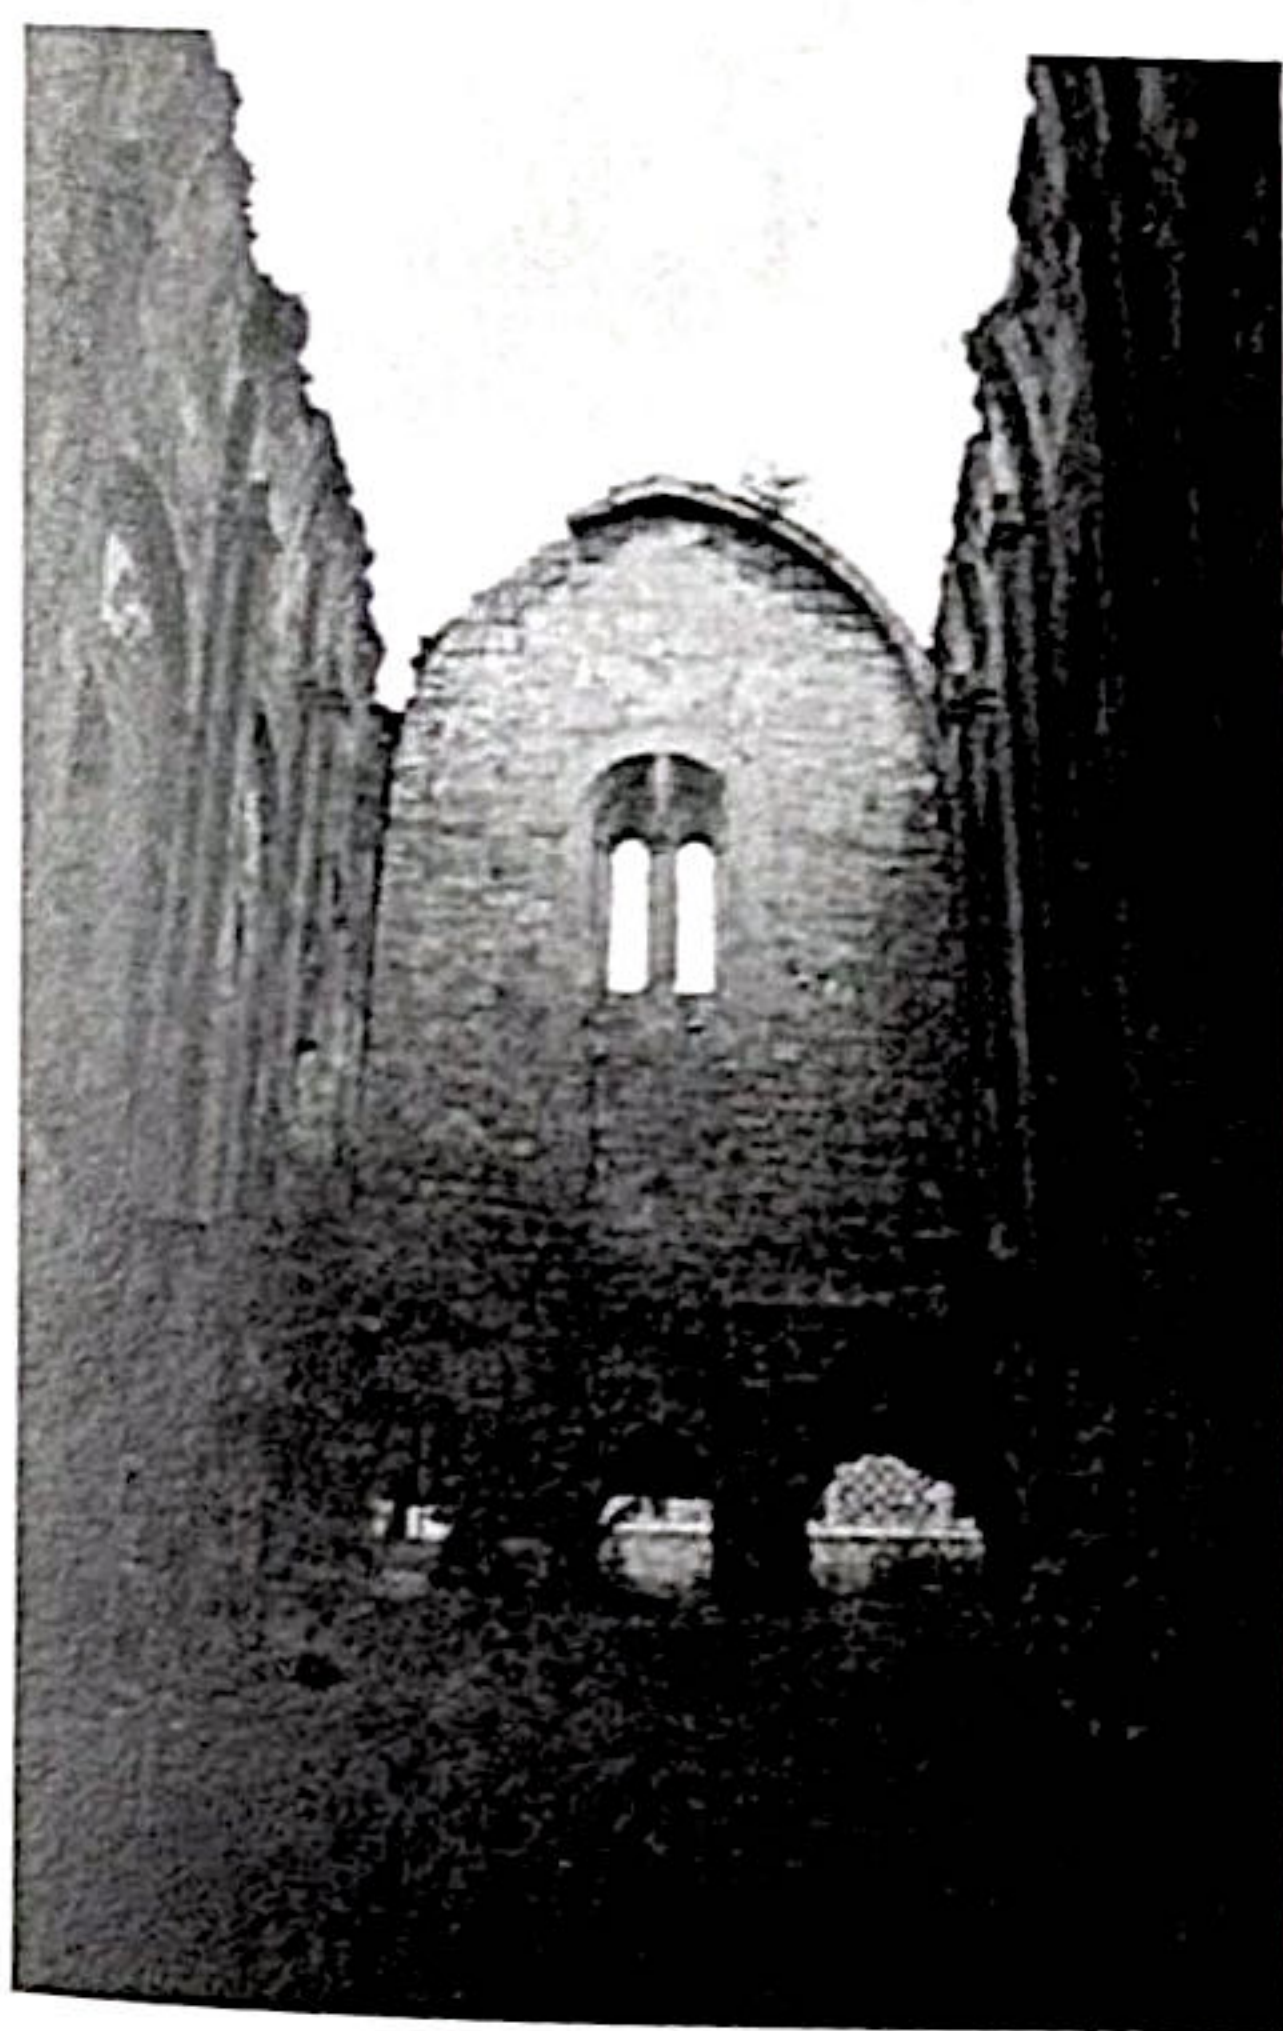
Fig. 2. Oshki - facade, dome, western arm

Oshki represented the Episcopal Church; It is a cross-domed temple with a free dome. For a long time, the existence of Oshki was shrouded in fog for Georgians; Only in 1902, when Ekvtime Takaishvili traveled to Tao-Klarjeti for the first time and accurately described the state of the monument, its existence became known. Oshki is currently in a deplorable state; If its restoration-strengthening is not done in time, it may collapse (Fig. 2.); Especially since this shoulder is in the zone of high seismic activity. The main load-bearing structures of the temple, including the dome, still exist, although they appear to be quite damaged. As can be seen from the pictures, the dome's neck has not yet lost its stability, although the arched roof of the western arm has completely collapsed (Fig. 2). With the intervention of the World Organization for the Protection of Monuments, an agreement was reached between the Tukul and Georgian sides regarding the restoration of Oshki by the Georgian side. The seismic damping system developed by us can be used in the restoration of this temple.[5]

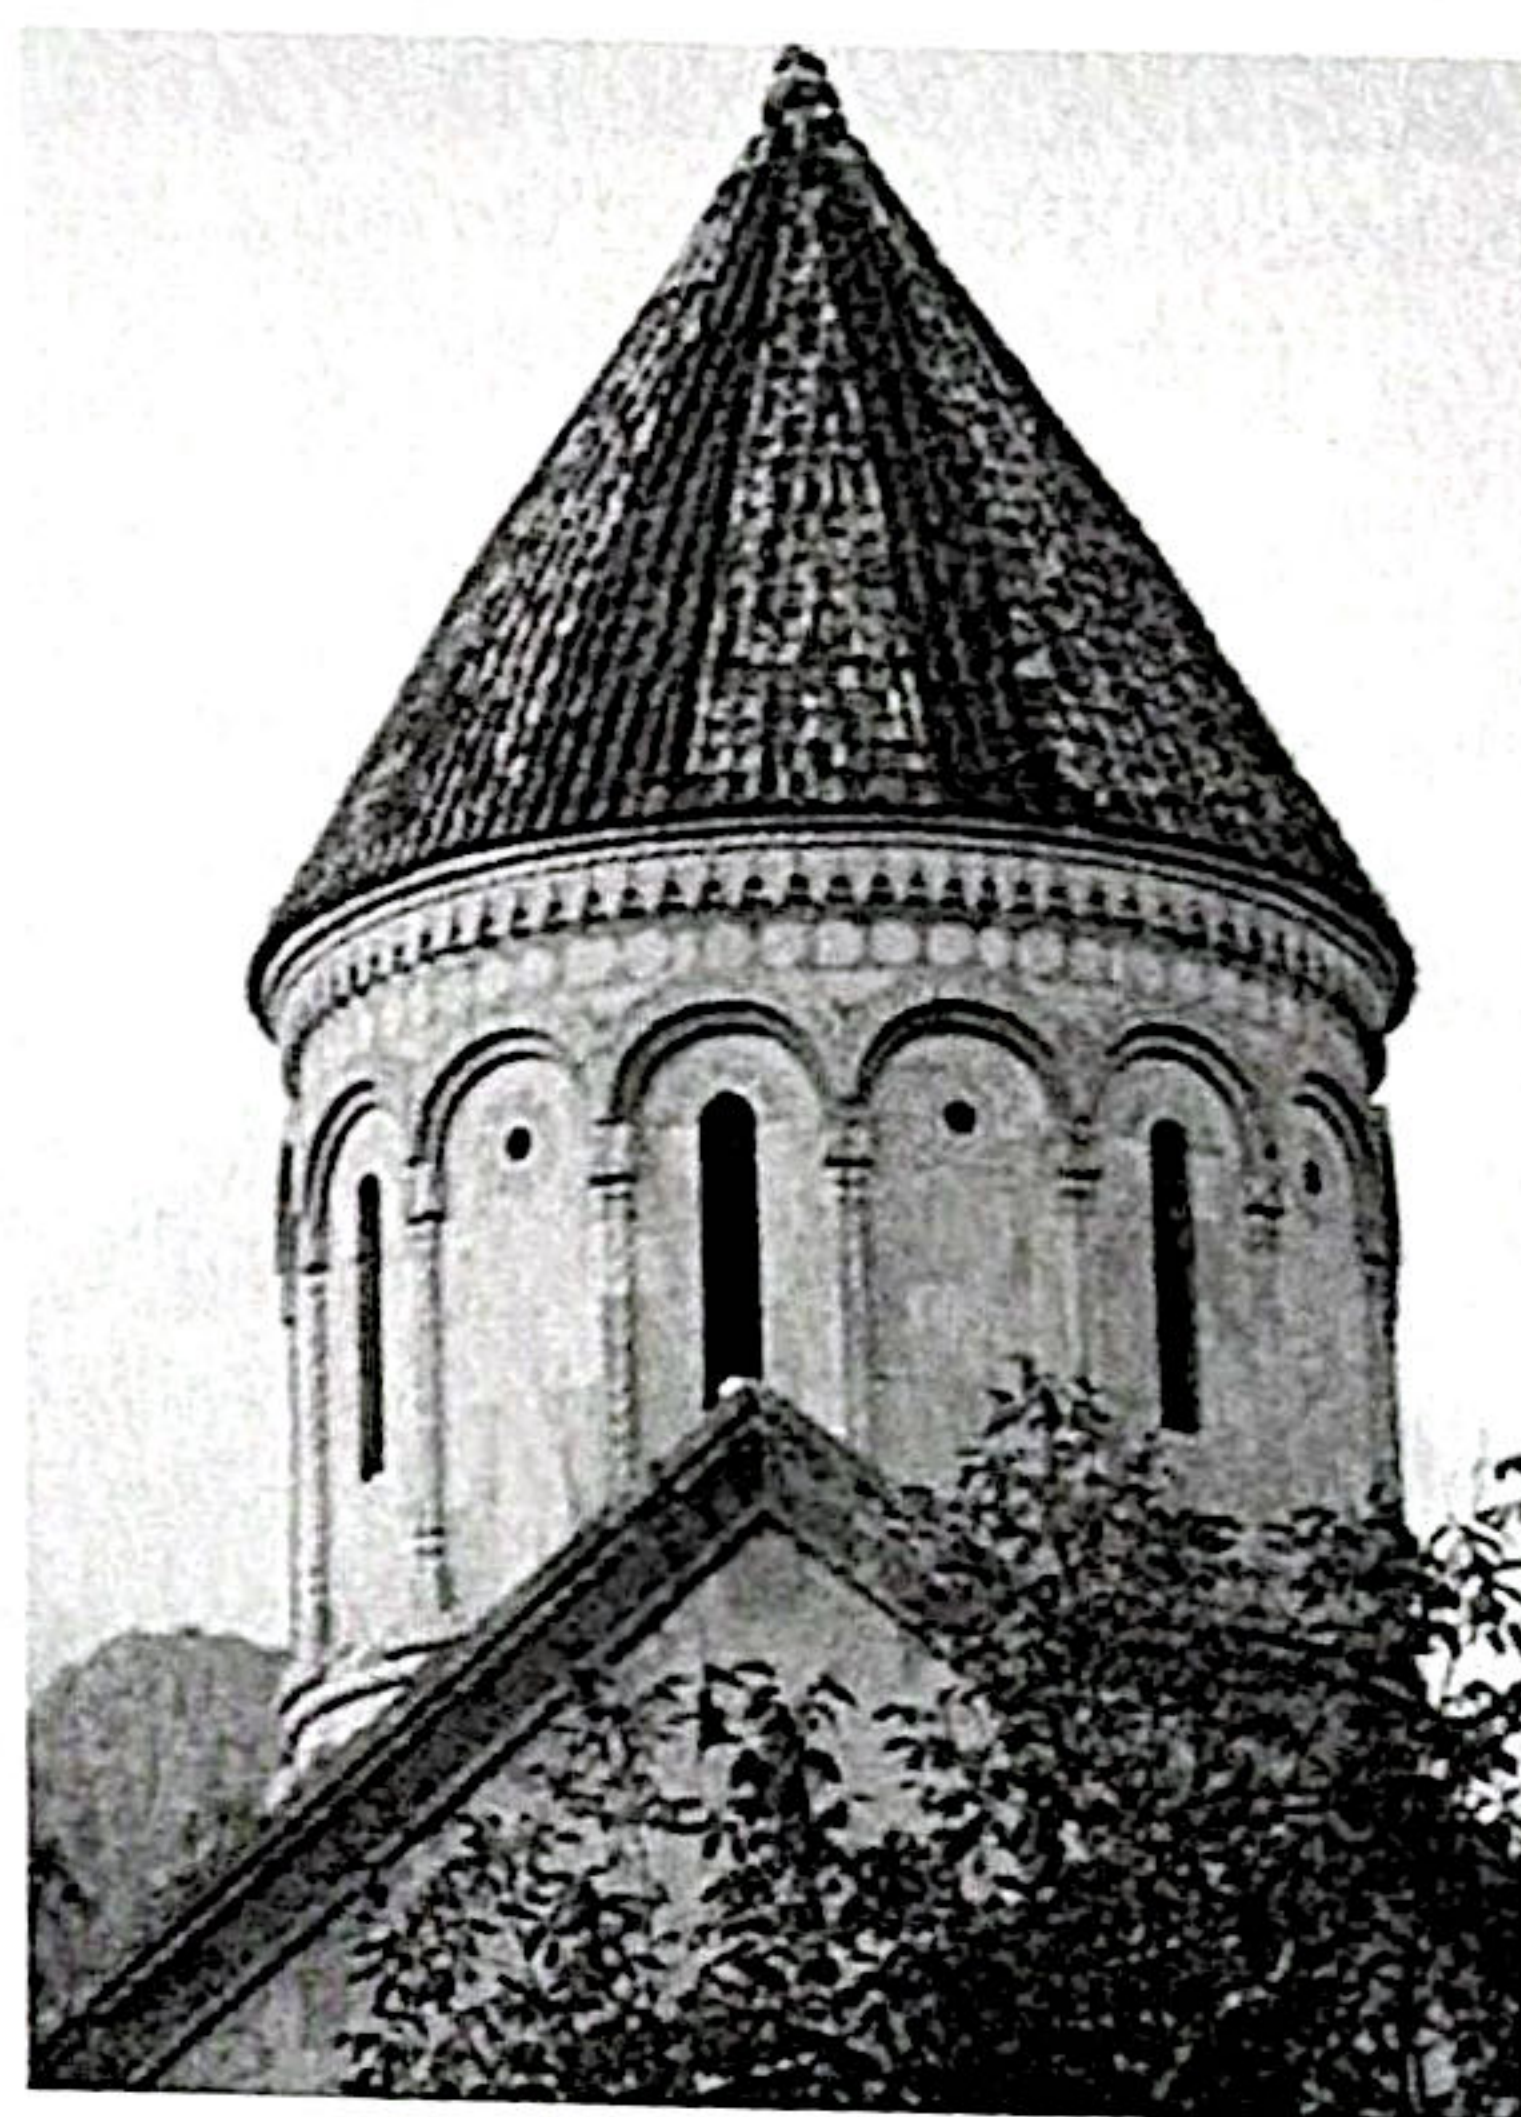
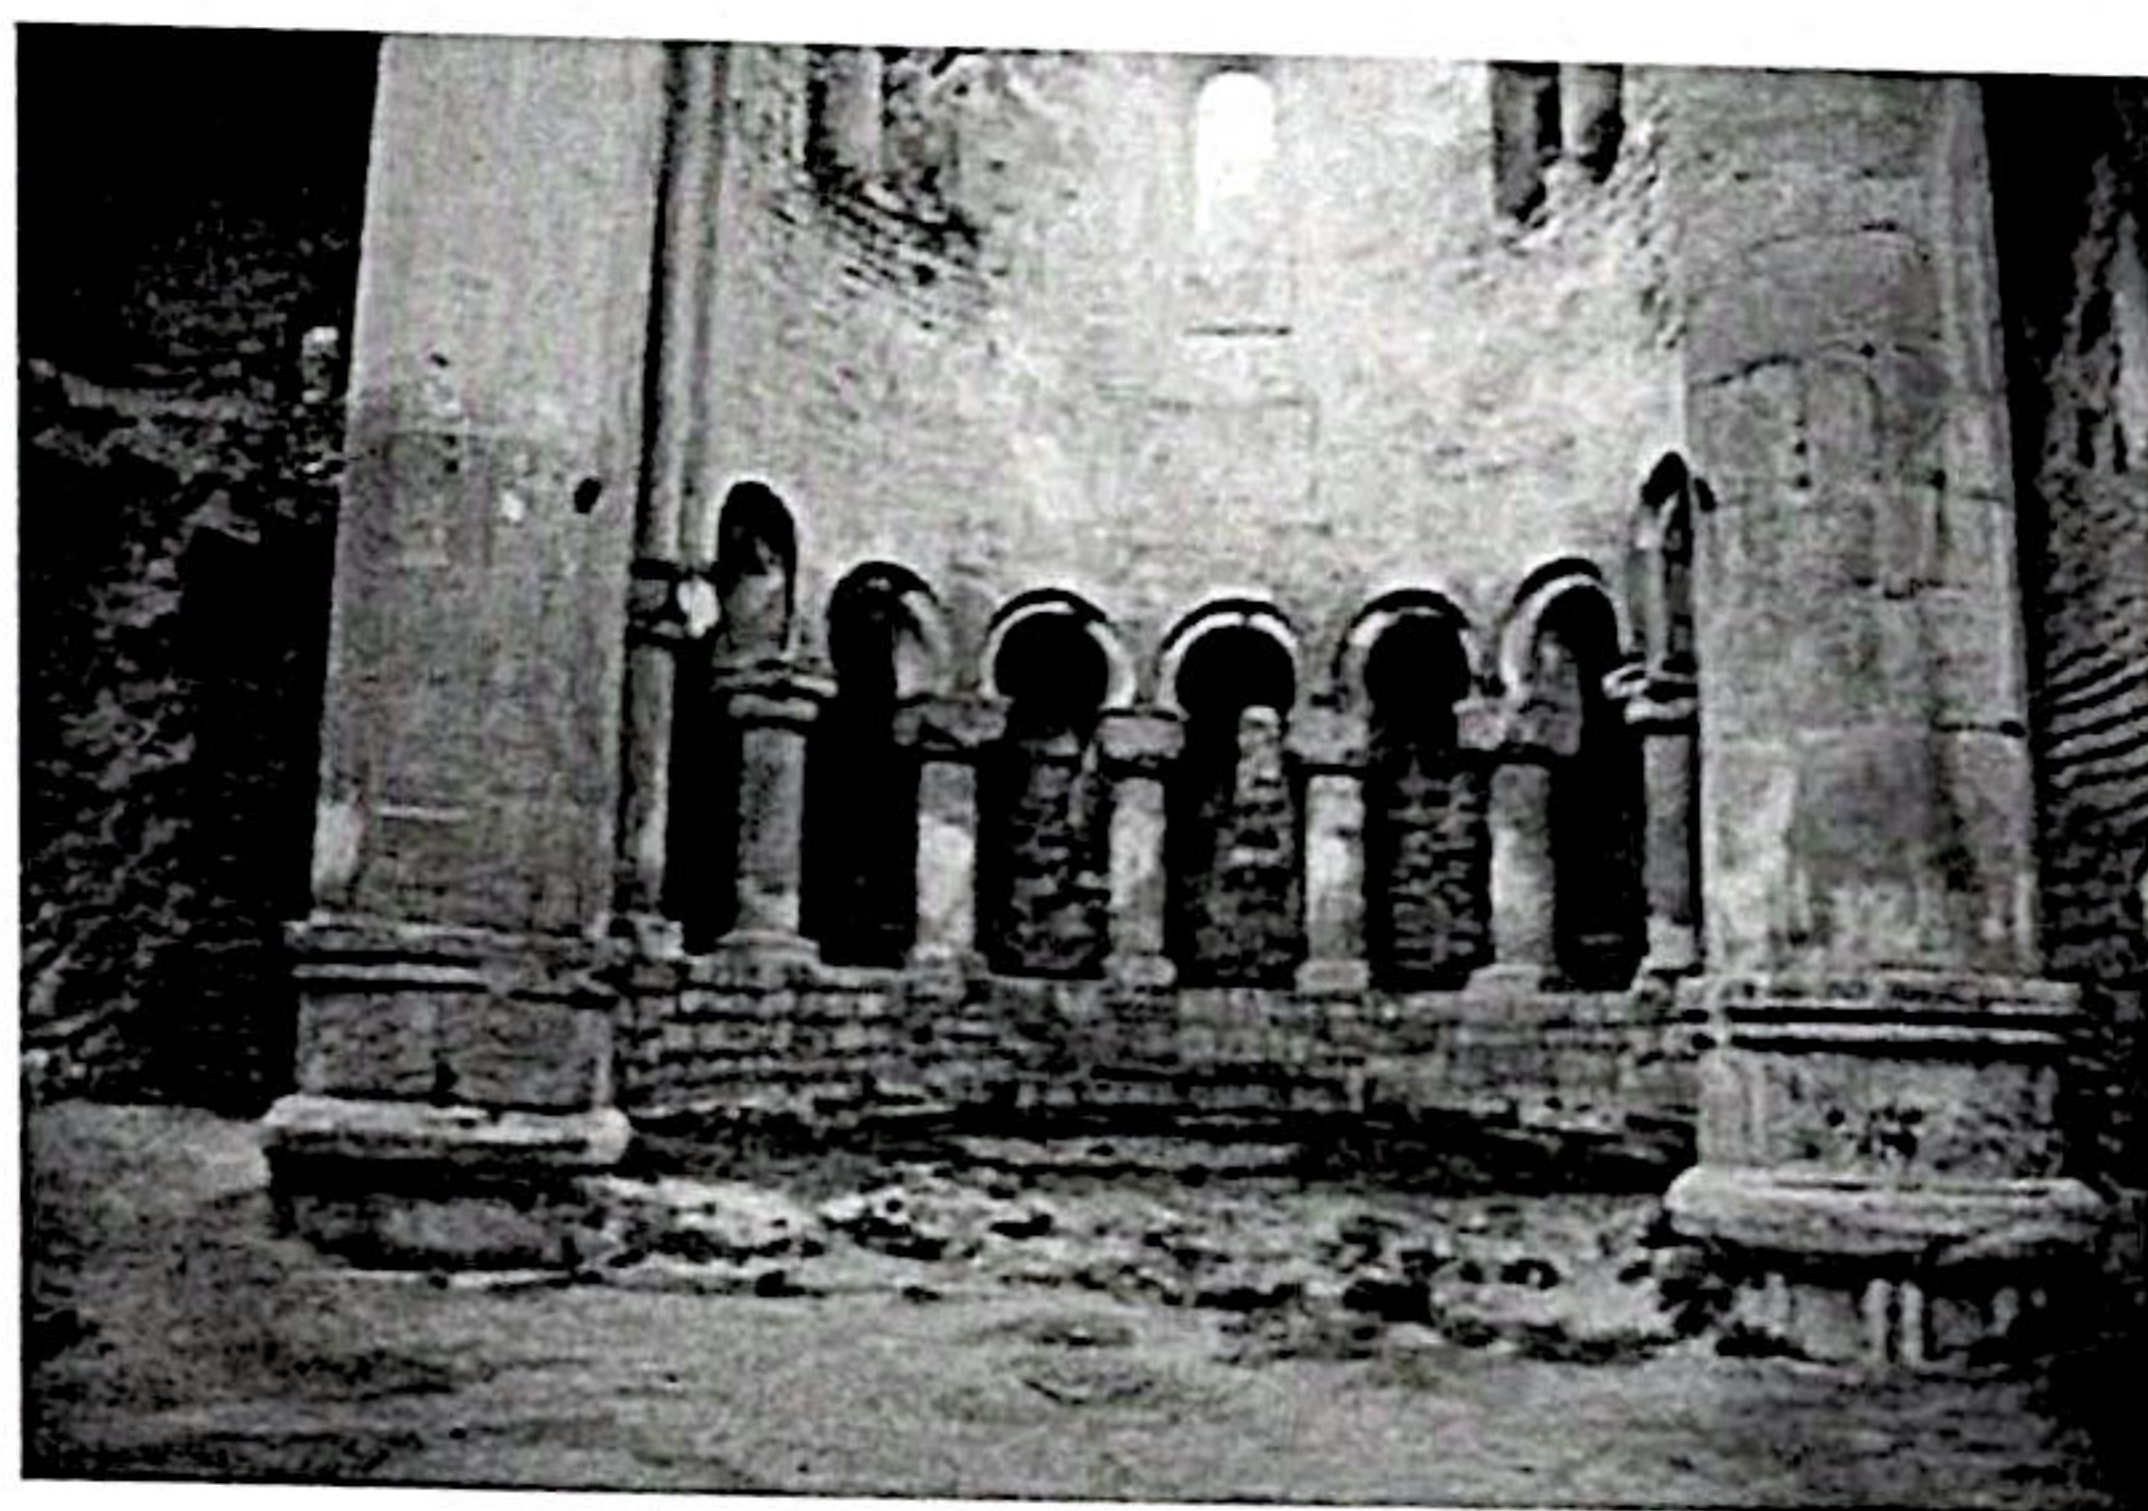
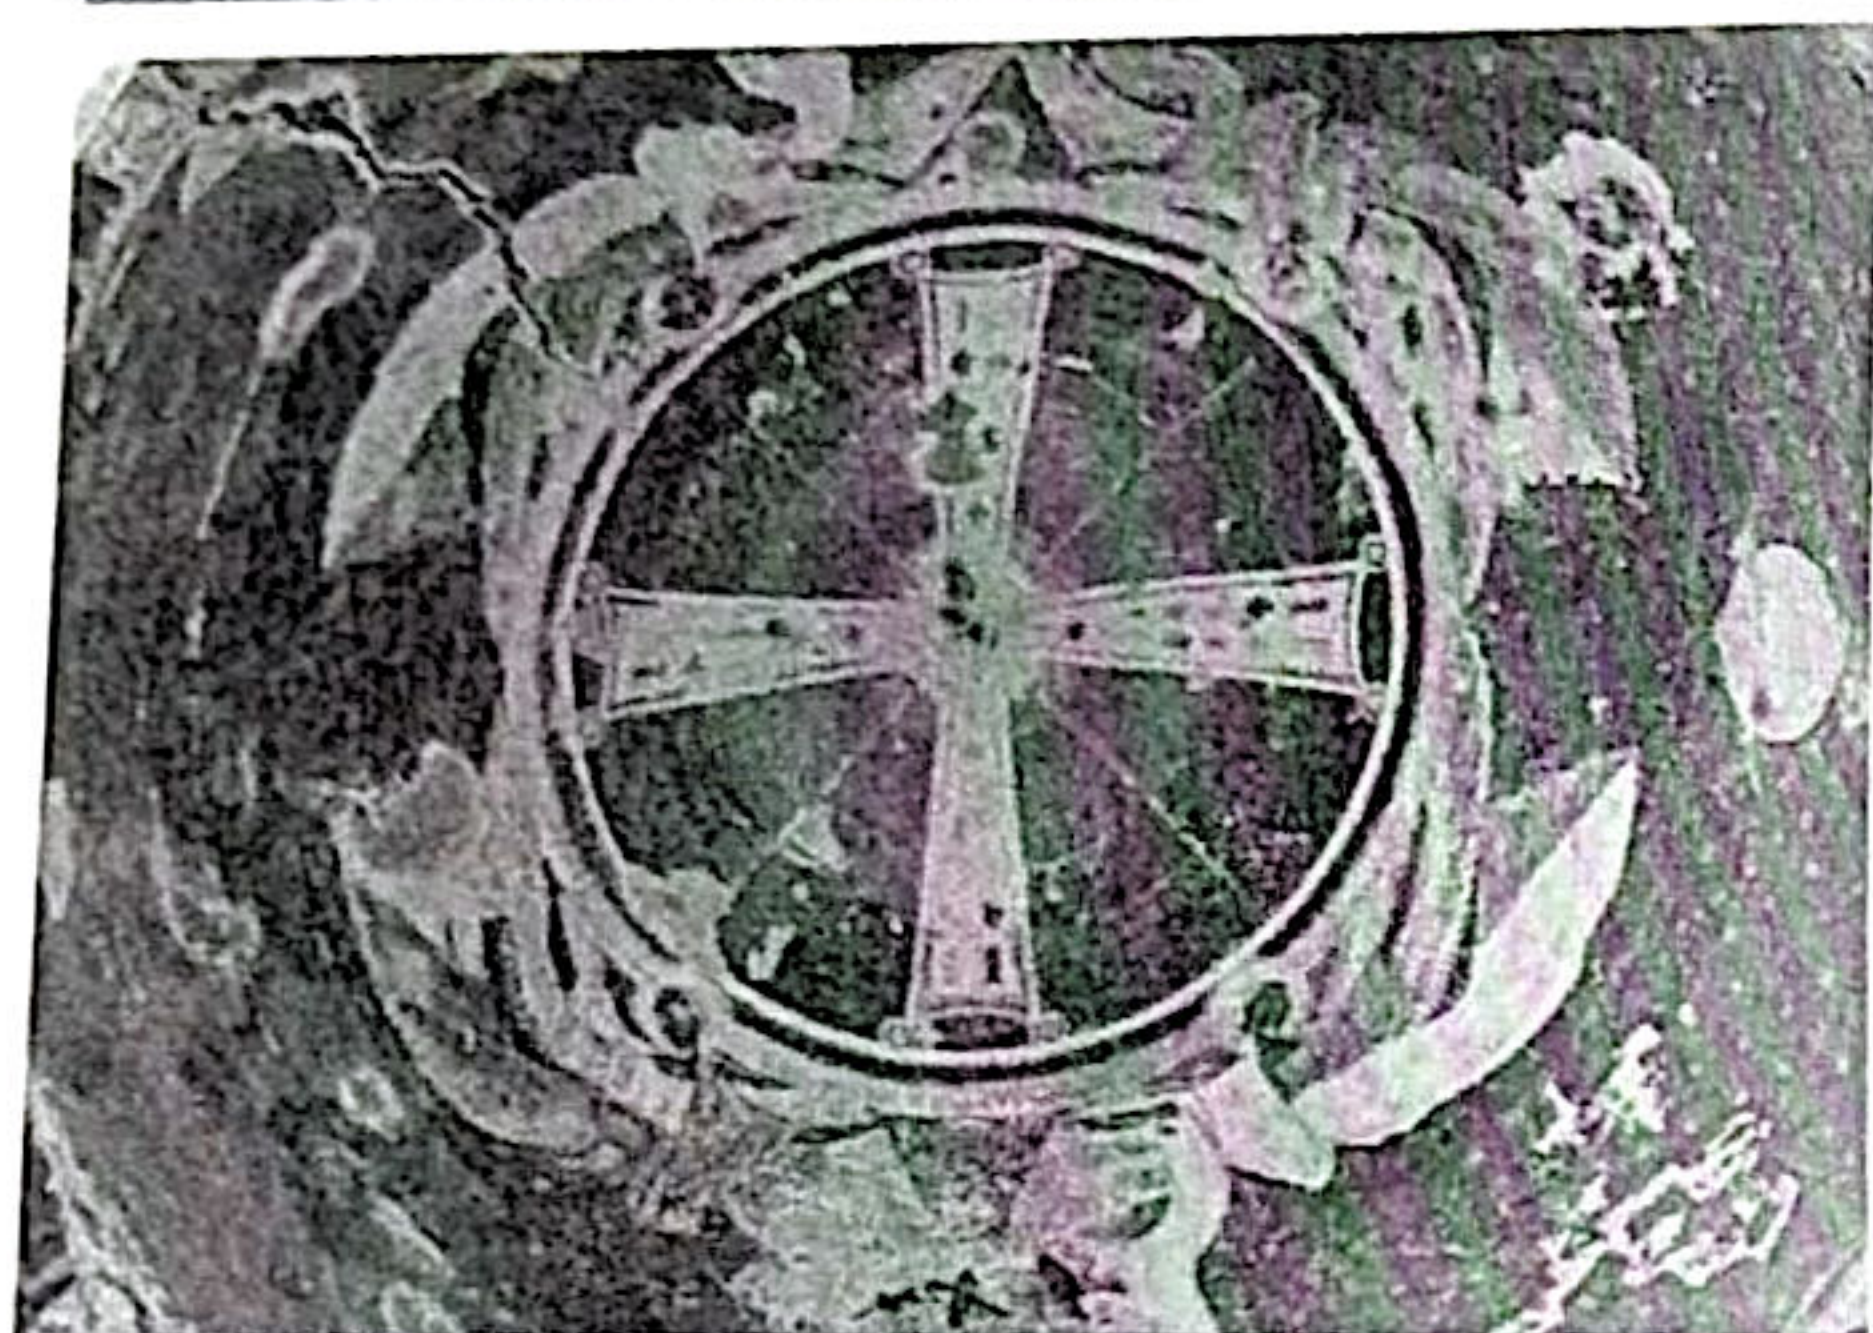
Fig. 3. Ishkhan - the throat of the dome, the altar, the dome from below

temple and which, like other temples, require immediate help. The temple is an elongated cross-domed building (Fig. 3). The dome is badly damaged, with a fairly wide crack running radially from the cleat to the support ring. The throat of the dome is also damaged; The arched (vaulted) roof of the elongated western arm has been completely collapsed. It is subject to restoration-strengthening.
