STUDY OF DAMAGE QUALITY OF TAO-KLARJETI TEMPLES

Abstract

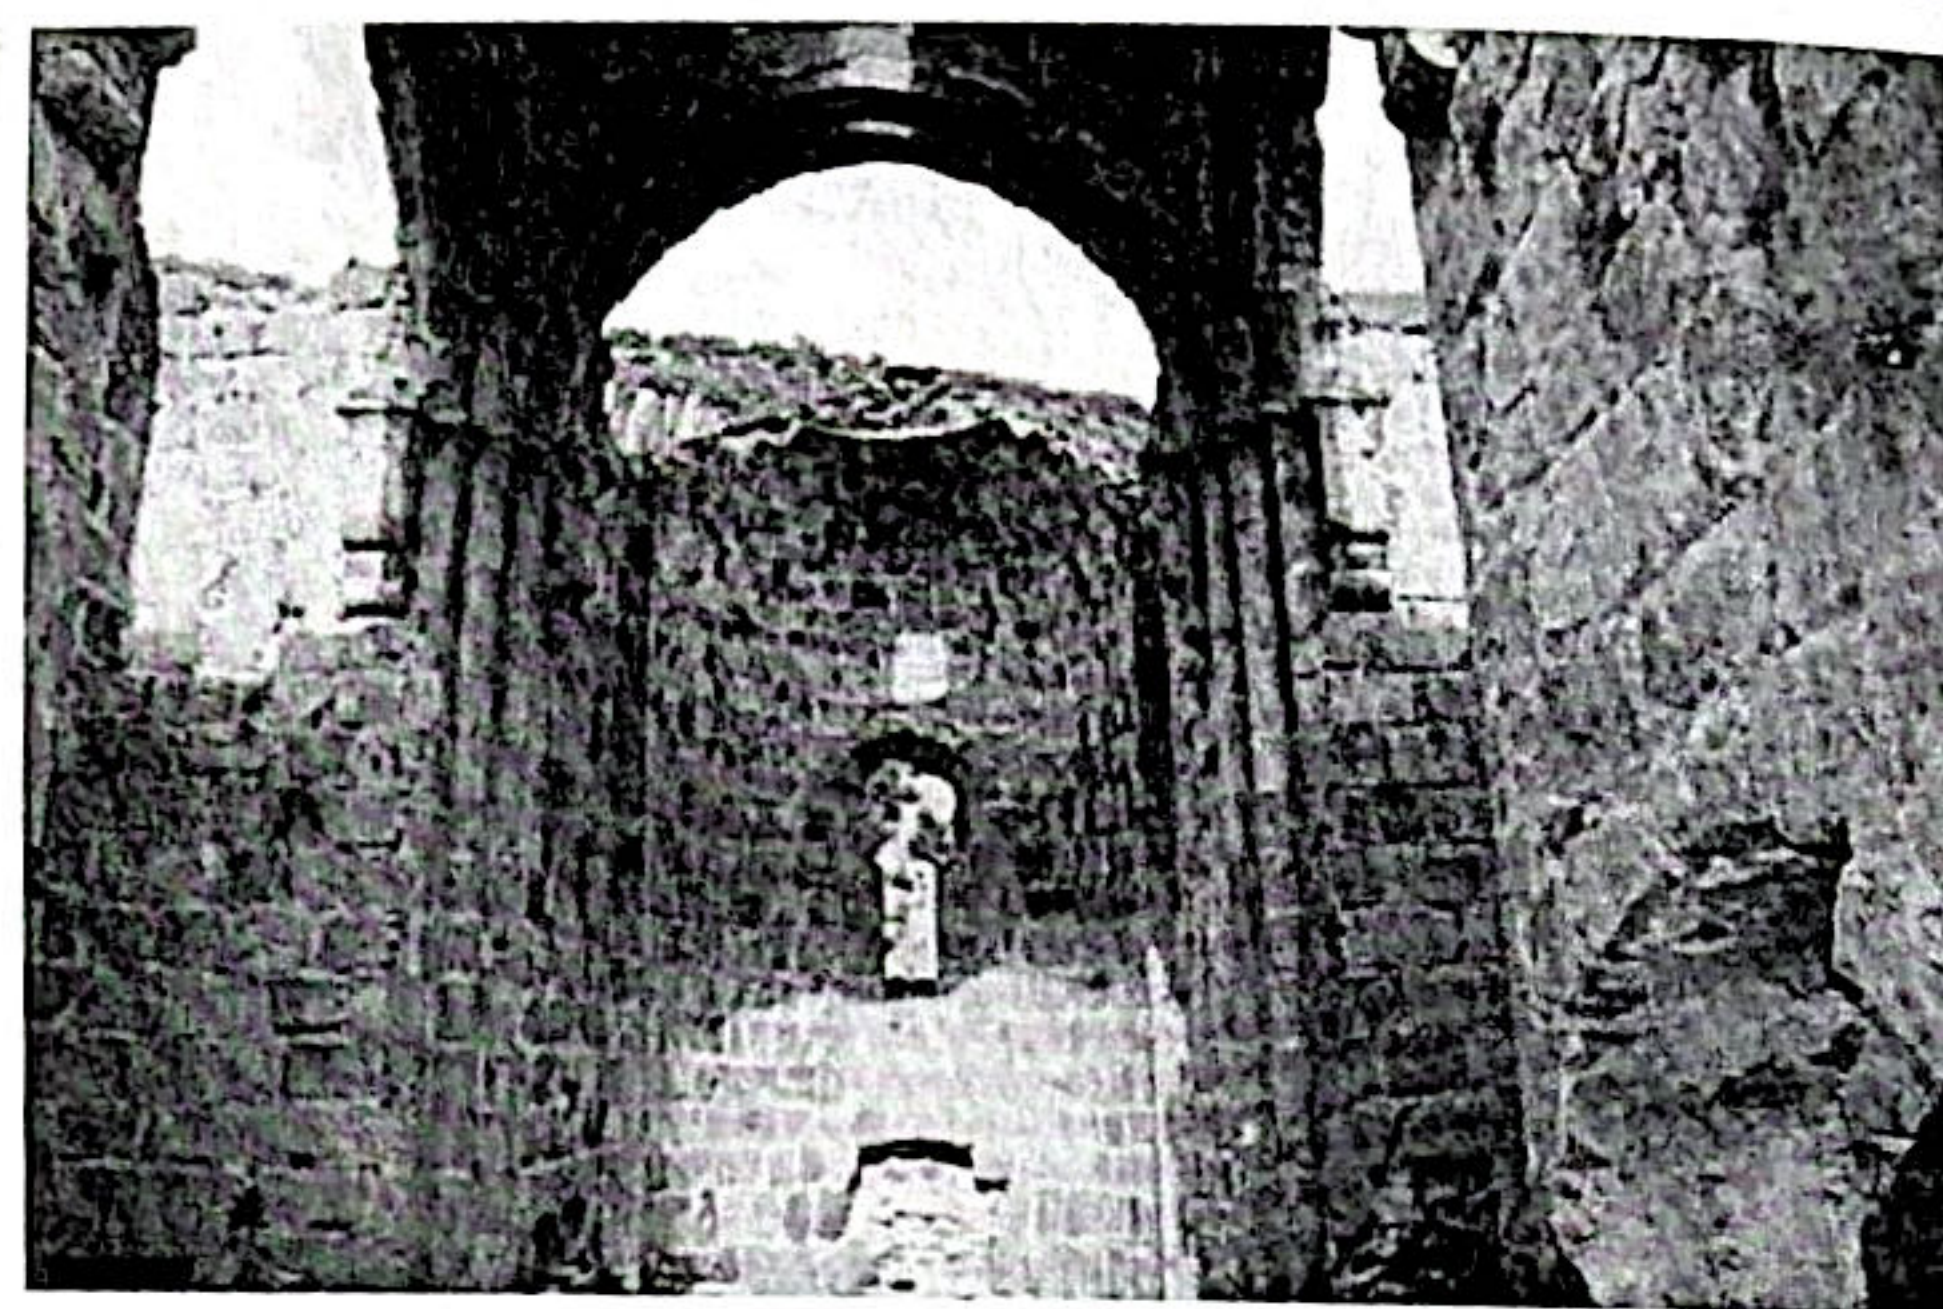
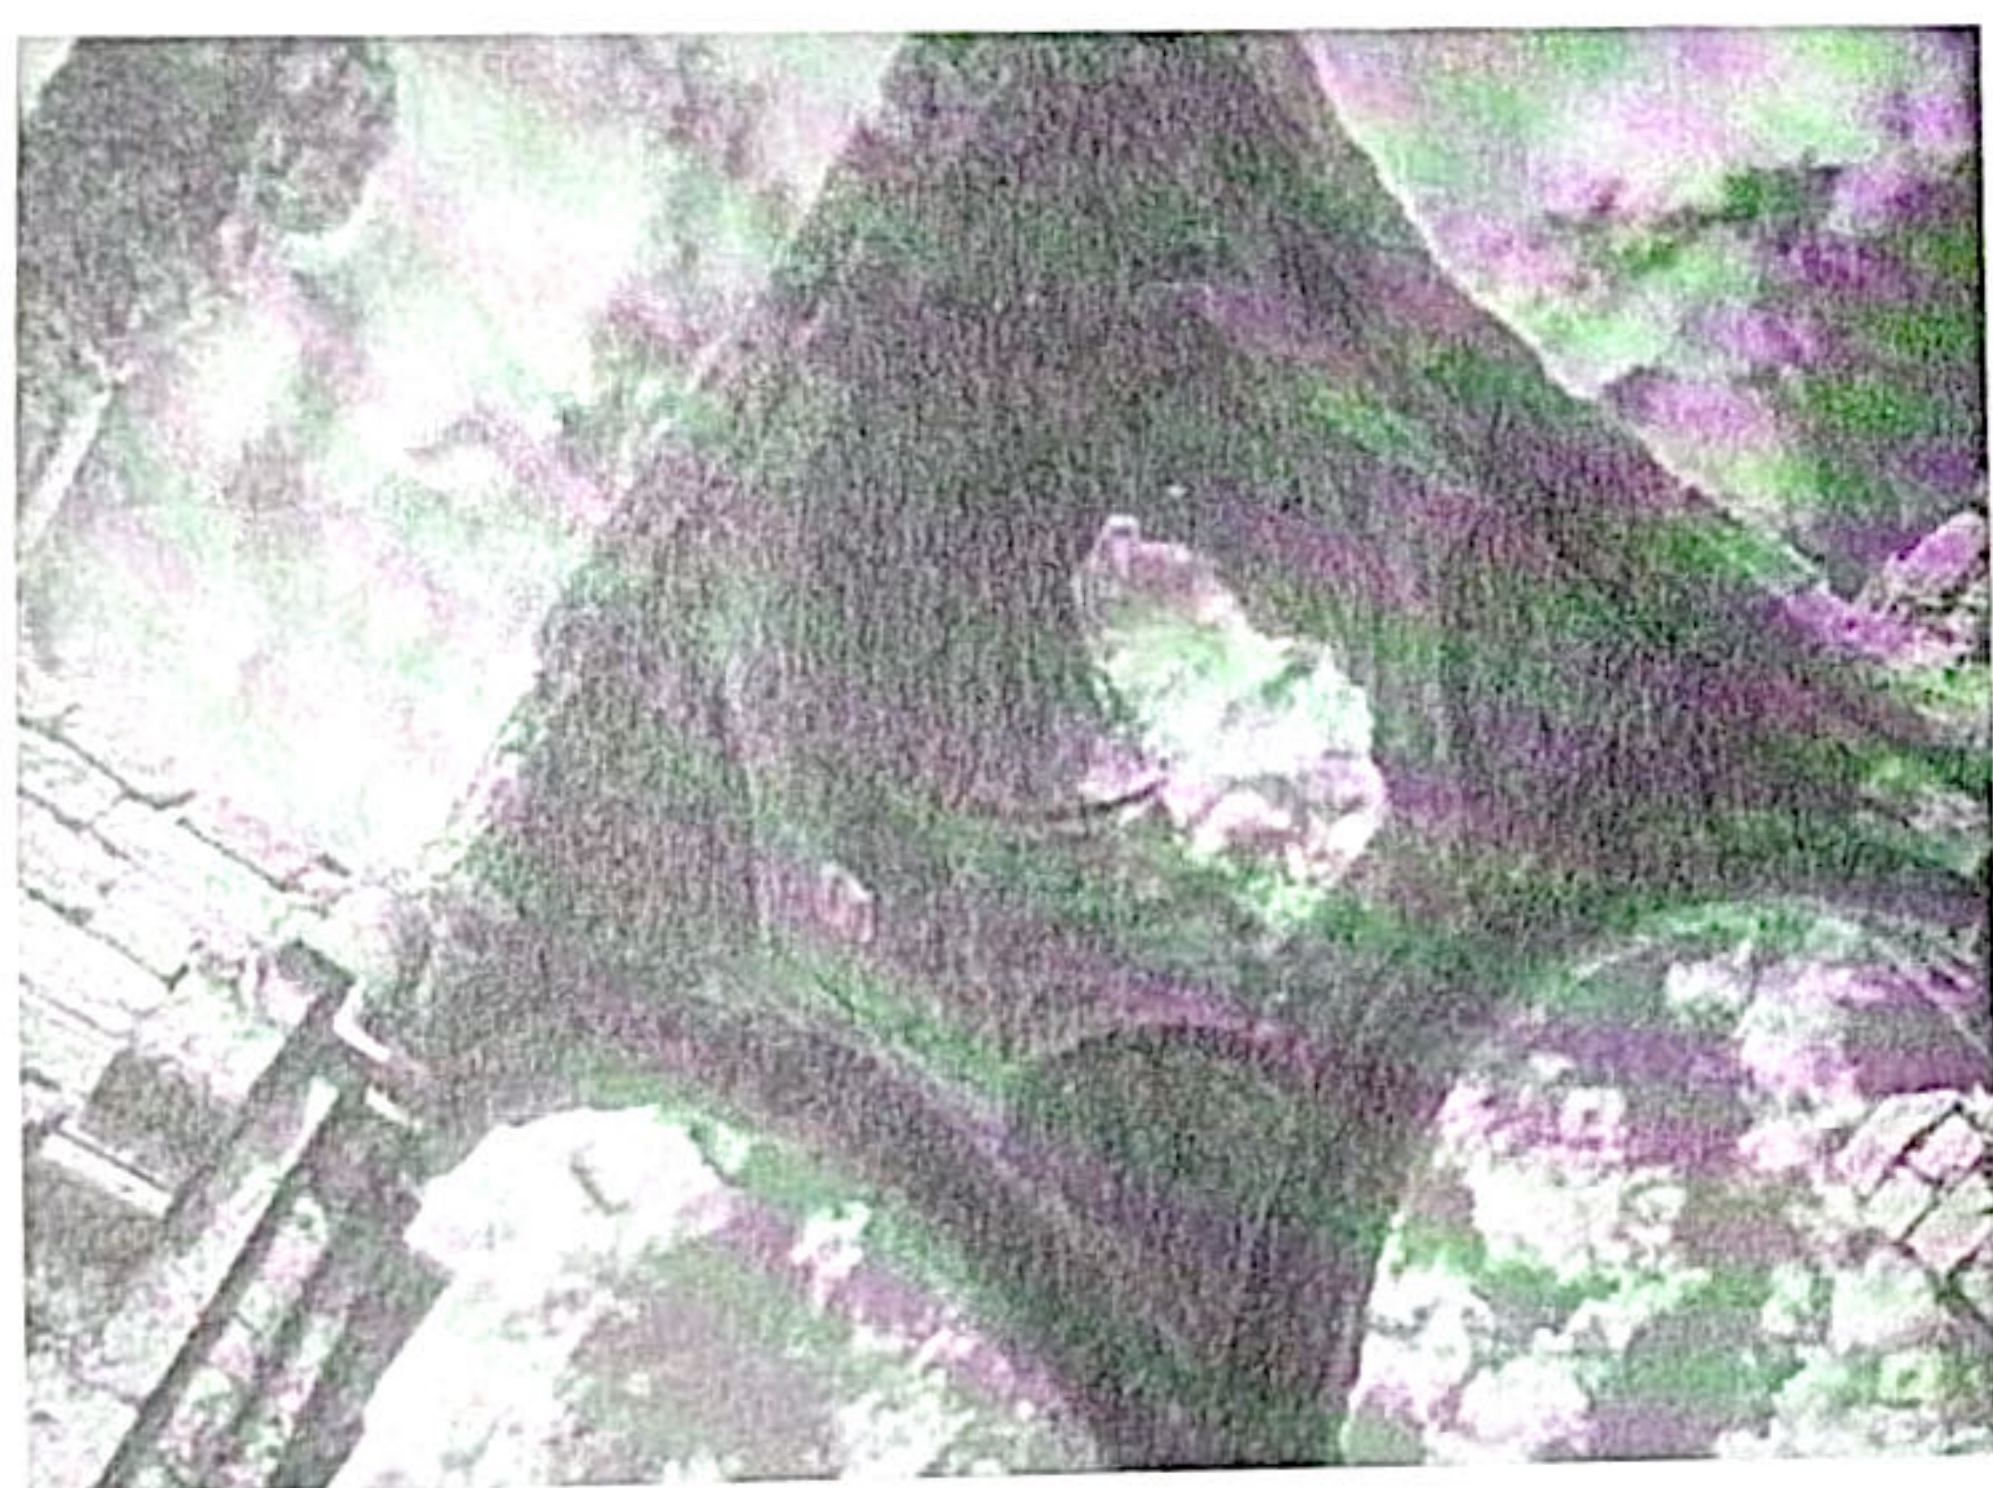
Fig. 4. Khandza

Khandza - the main temple is in the shape of an inscribed cross - it is a cross-domed temple (Fig. 4). Its dome rested on the walls of the apse on the east side, and on two piers on the west side, the remains of which have only survived. The pictures taken before 2007 show that the dome still existed (Fig. 4), and in 2010 - the dome has collapsed (Fig. 4). However, the neck of the dome is visible, on which, in case of restoration of the temple, it is possible to arrange a new dome. In this case too, it is possible to use the seismic suppression system developed by me.

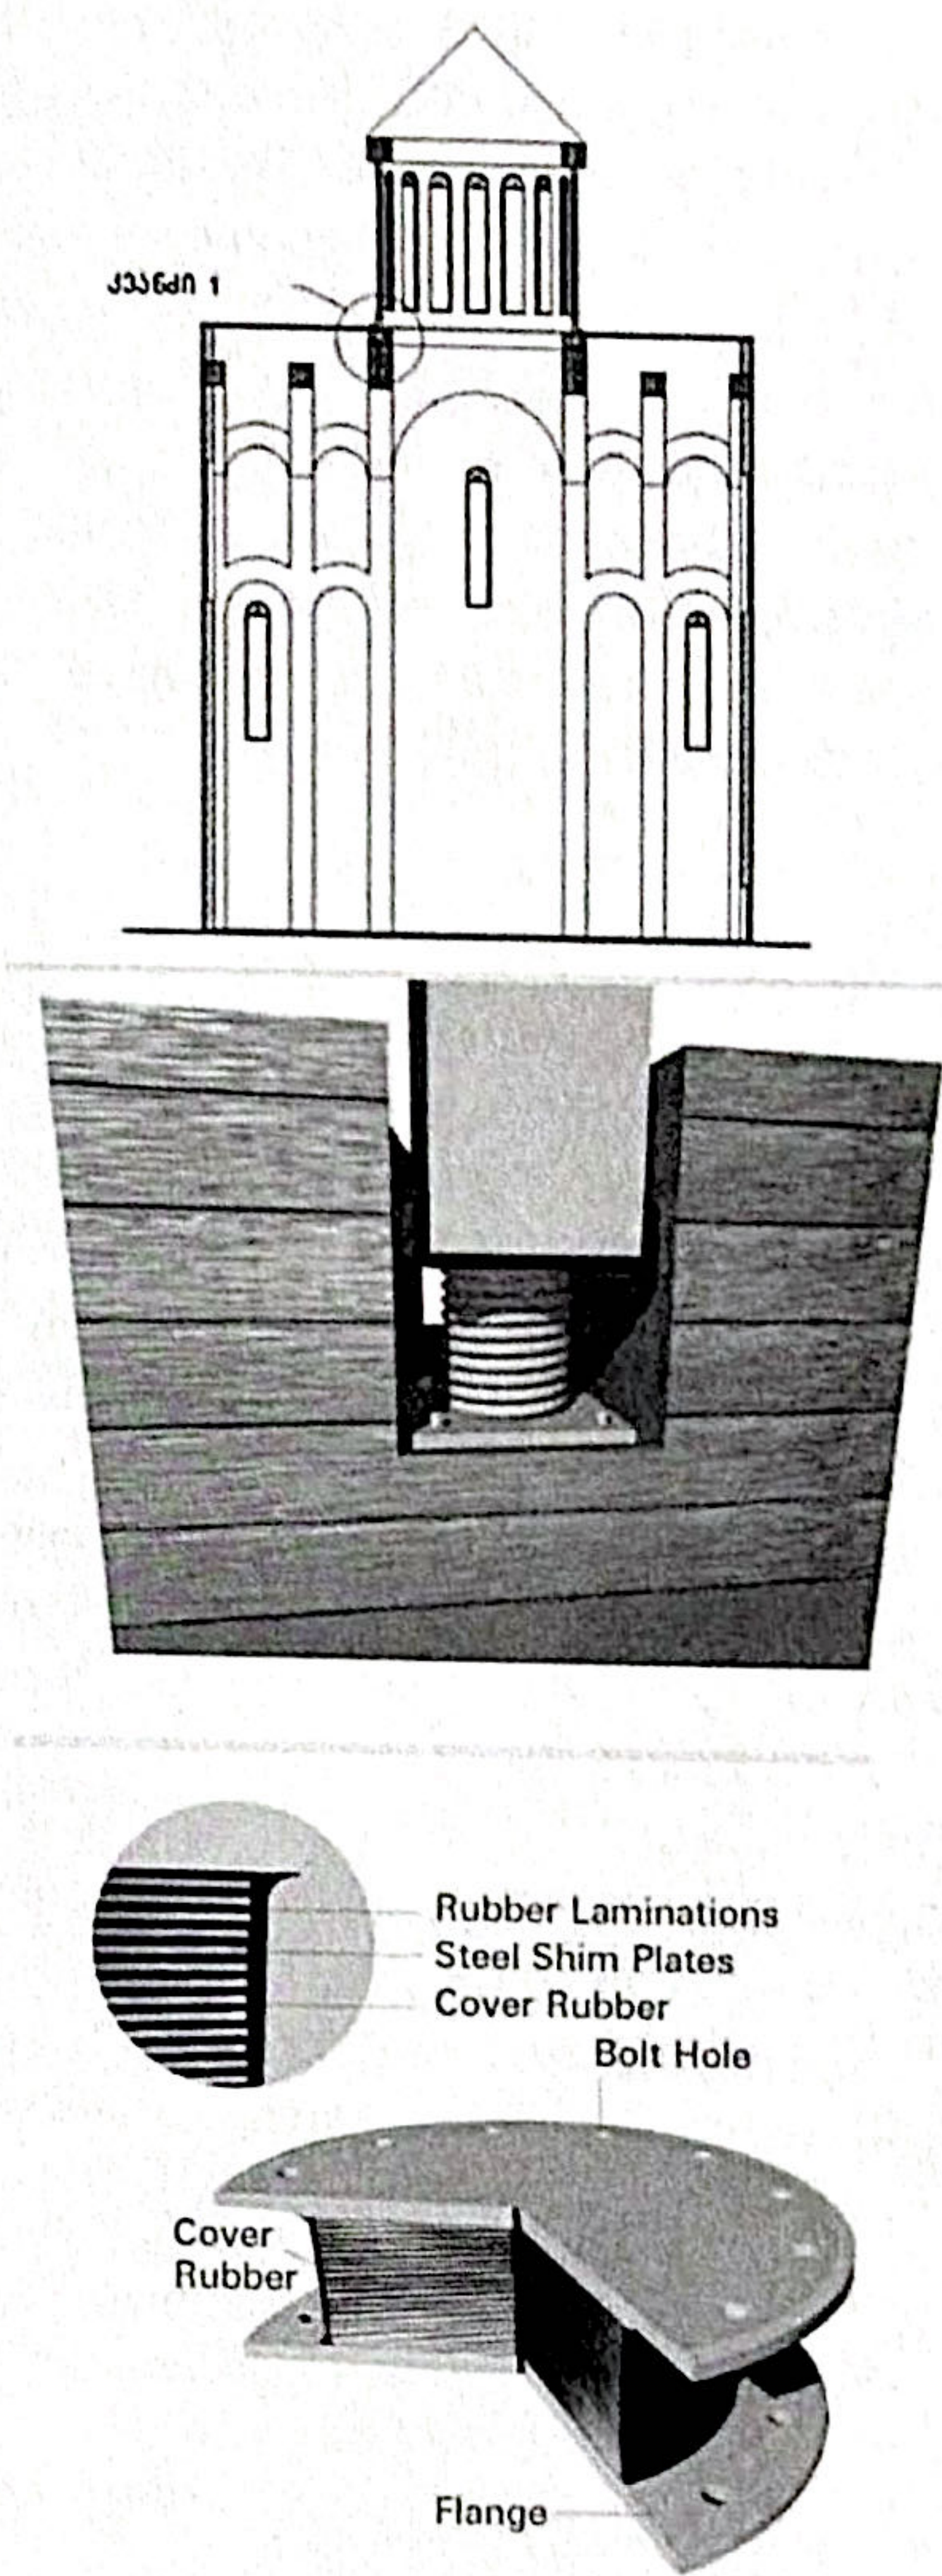
Fig. 5. temple slit; Seismic Isolating Rubber

The constructional solution of seismic damping systems is as follows: a reinforced concrete grooved belt is arranged on the support ring, which is also the binder of the arches. Metal sheets will be anchored in the groove, on which the damper is mounted: rubber-metal (widely used in viaducts and overpasses in the places of support of the Mali structure) and spring. The throat of the dome is connected to the damper by a valve. Holes are made in the throat of the dome (shown in the diagram below), in which metal anchors are placed to limit vertical movement. As far as is known, this type of construction has not yet been used in practice, so it is a novelty.

Rubber-metal dampers of the new seismic suppression system were used for seismic isolation. The Seismic Isolating Rubber Bearing consists of alternating laminations of thin rubber layers and steel plates (shims), bonded together to provide vertical rigidity and horizontal flexibility.

Vertical rigidity assures the isolator will support the weight of the structure, while horizontal flexibility converts destructive horizontal shaking into gentle movement.

Rubber-metal dampers, as well as spring-type dampers, may be arranged in the structure arranged in the throat of the dome of the temples under construction. Based on their positive and negative characteristics, as well as the calculation, it should be decided which of these

types of dampers we will choose for temples (Fig. 5).
